**Nine Career Fire Fighters Die in Rapid Fire Progression at Commercial Furniture Showroom — South Carolina**

Fire Fighter Fatality Investigation and Prevention Program

*A summary of a NIOSH fire fighter fatality investigation*

February 11, 2009

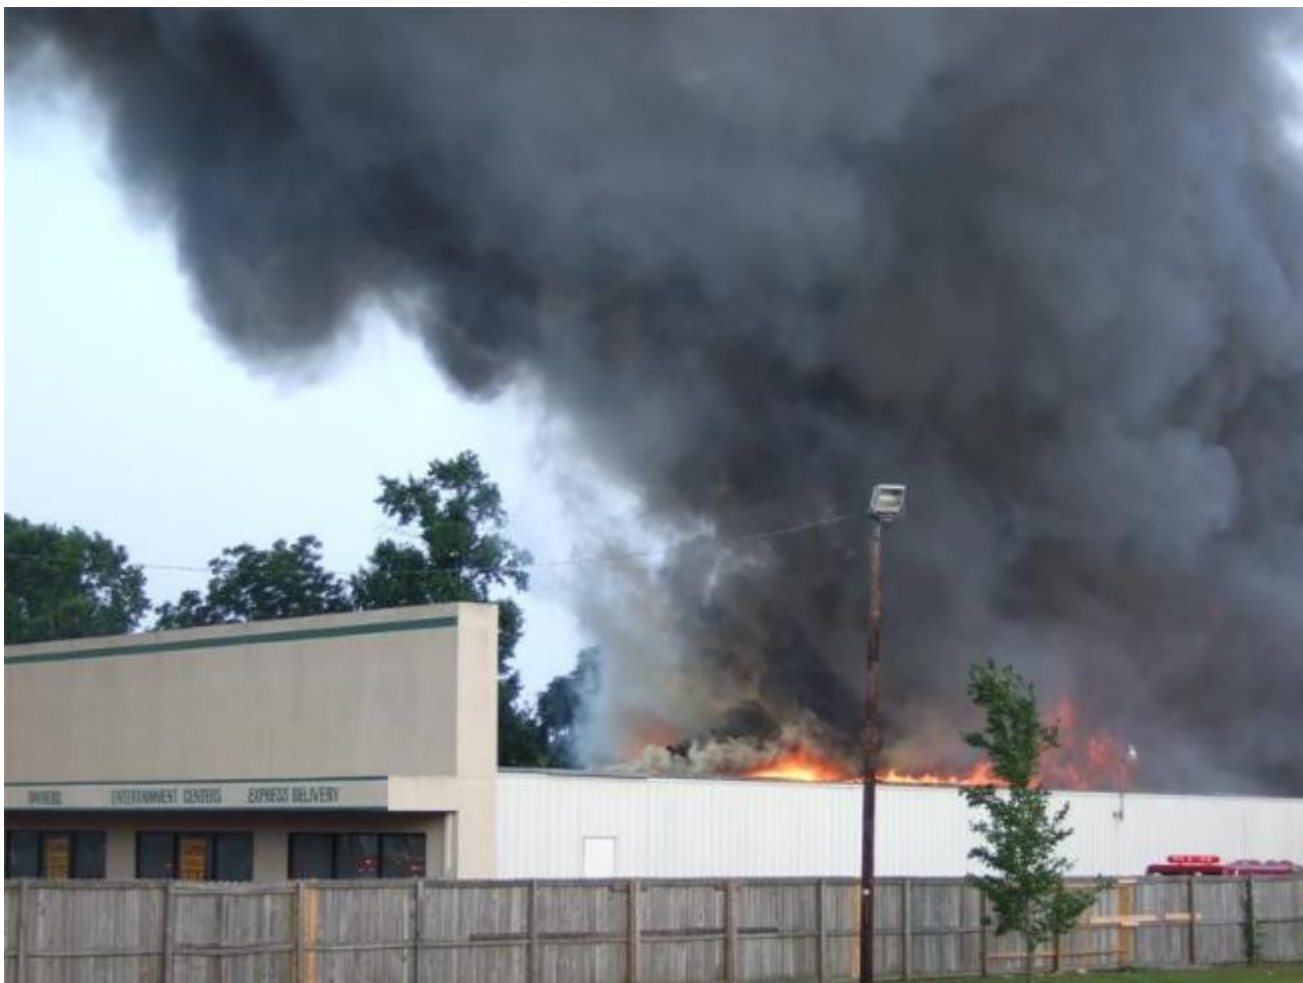
**Photo 1. Time approximately 1924 hours. Fire is visible over showroom roof. Smoke is dark gray in color and becoming turbulent. The flames may not have been visible from front parking lot or close to the building on the D-side. (Photo courtesy of Dan Folk.)**

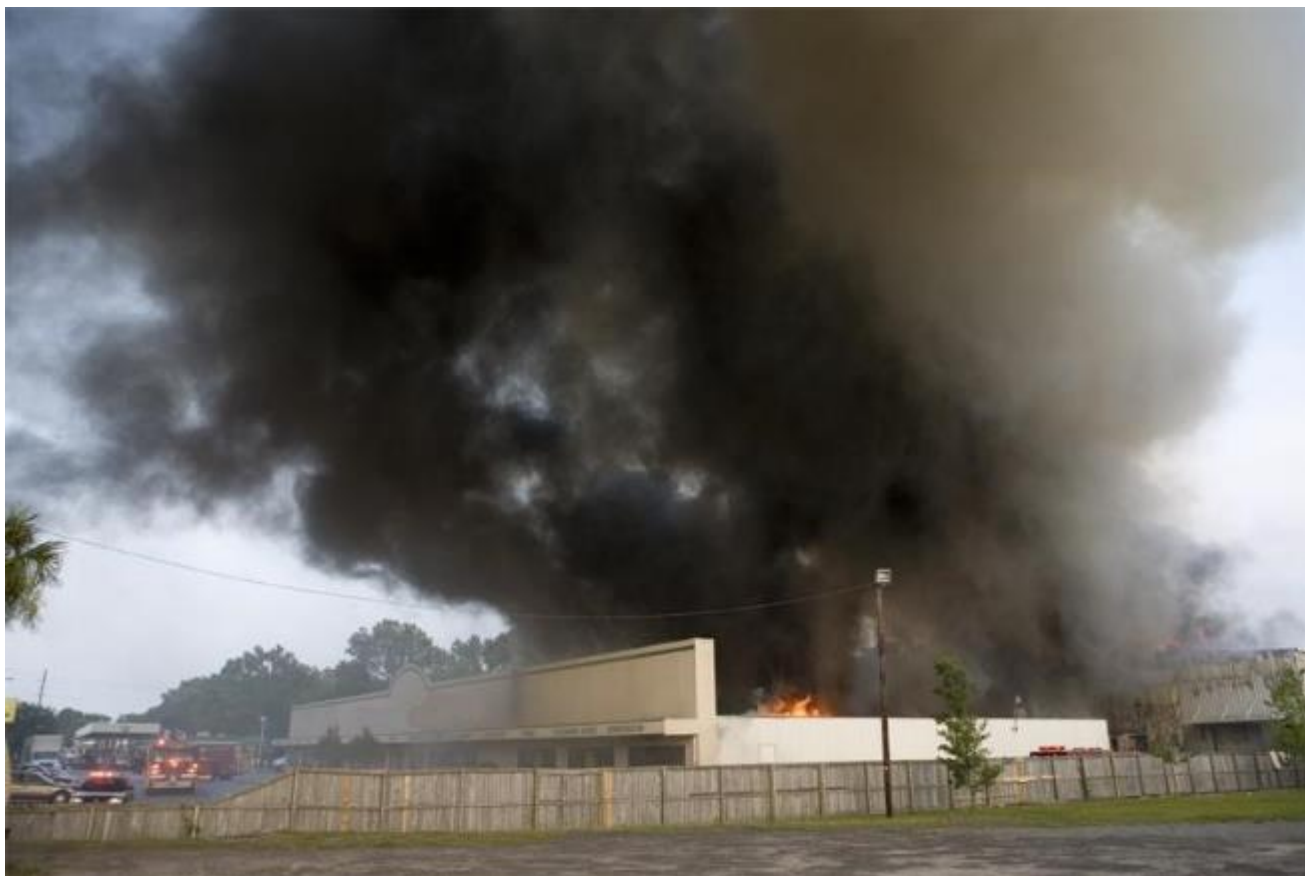
**Photo 2. Time approximately 1930 hours. Note how smoke has changed to dark black color indicating it is rich with products of incomplete combustion. Note Ladder 5 and Engine 11 in front of structure as well as fire department vehicle in lower left corner. The top of Engine 10 is just visible over the fence at the lower right. *(Photo courtesy of Associated Press, Alexander Fox photographer.)***

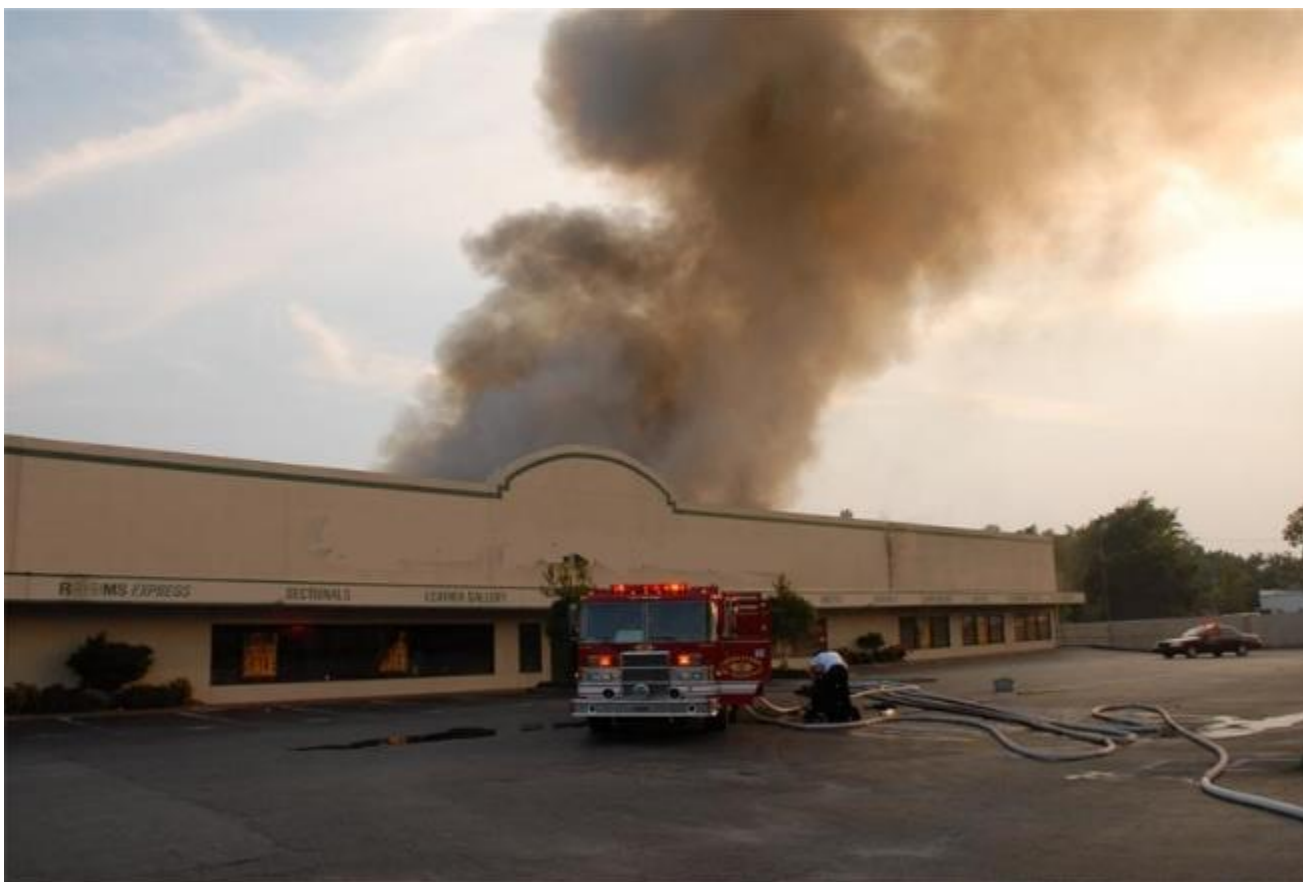
**Photo 3. Time approximately 1934 hours. Note lack of any fire personnel in front of structure. At this point, the E-11, L-5, E-16, E-15, E-19, and E-6 crews are inside the showroom. Also note how the color of smoke column appears different from previous photo which may be due to the angle of the photograph and position of the sun. (Photo courtesy of Police Department, Bill Murton, photographer.)**

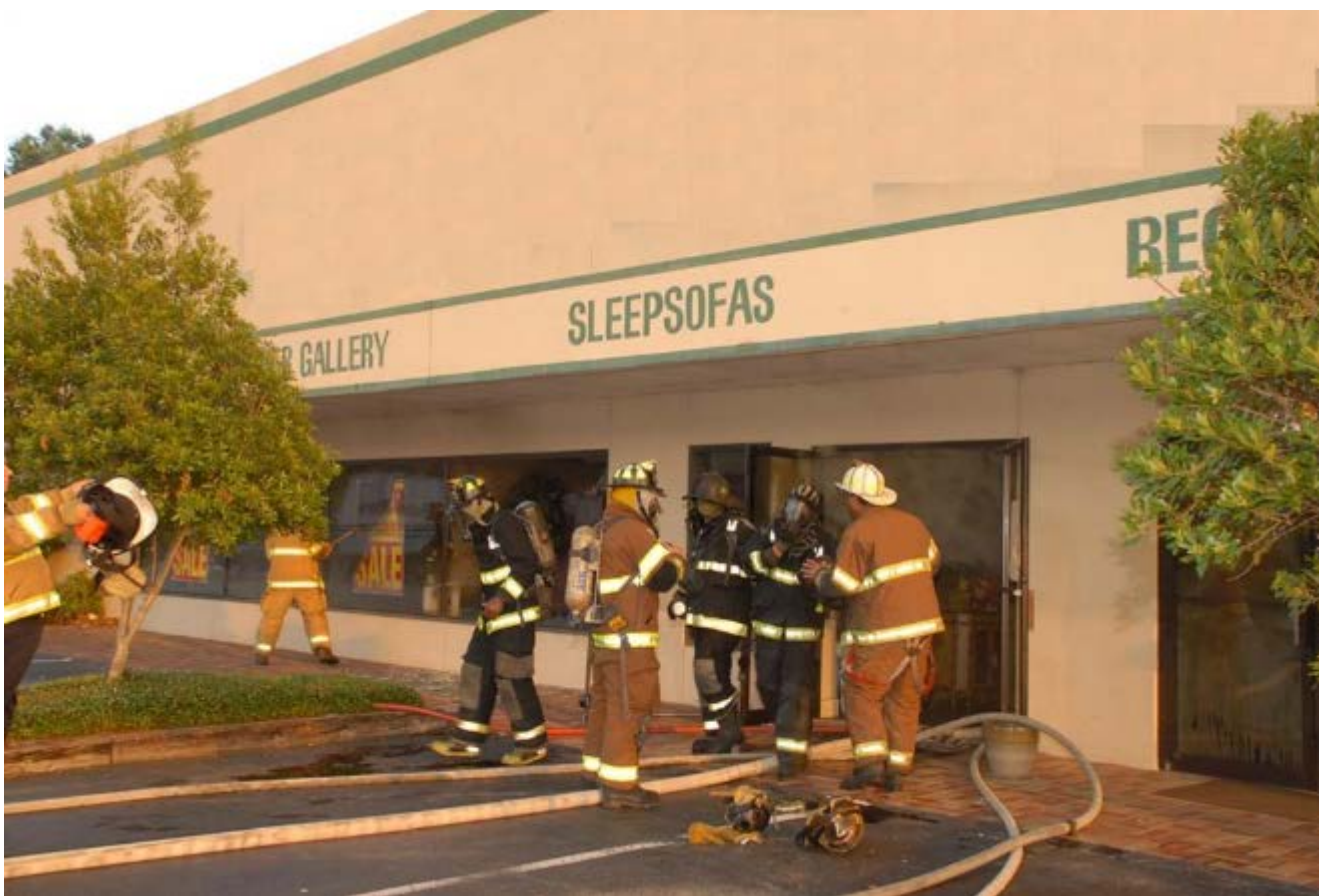
**Photo 4. Last surviving members of the initial attack crews exit showroom at approximately 1935 hours.** *(Photo courtesy of Police Department, Bill Murton, photographer.)*

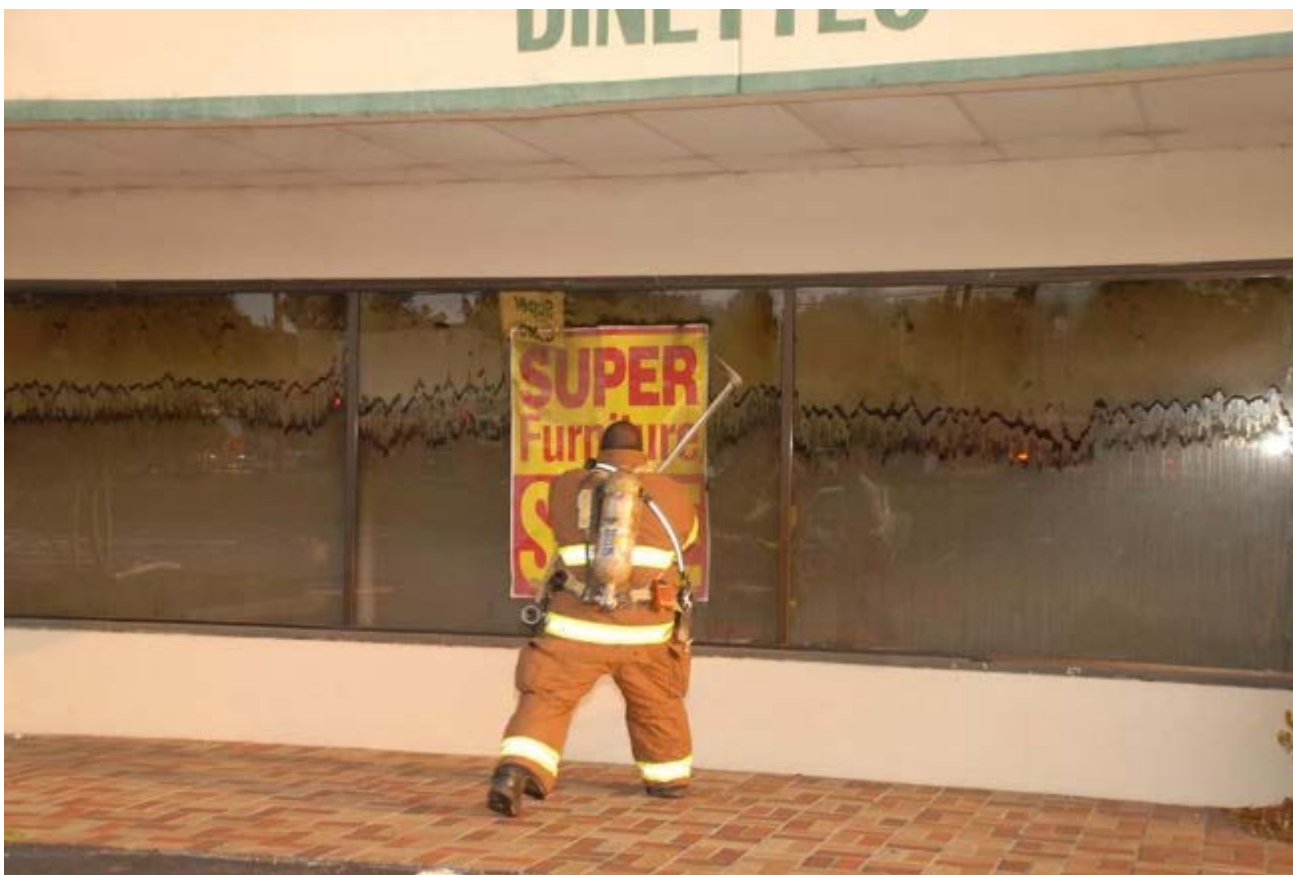
**Photo 5. Time approximately 1935 hours. Mutual aid fire fighter breaking showroom front window. Photo taken just prior to mutual aid department making rescue attempt in front showroom. Note the heavy tar stains on the windows indicating the smoke inside the showroom is rich with flammable products of incomplete combustion. (Photo courtesy of Police Department, Bill Murton, photographer.)**

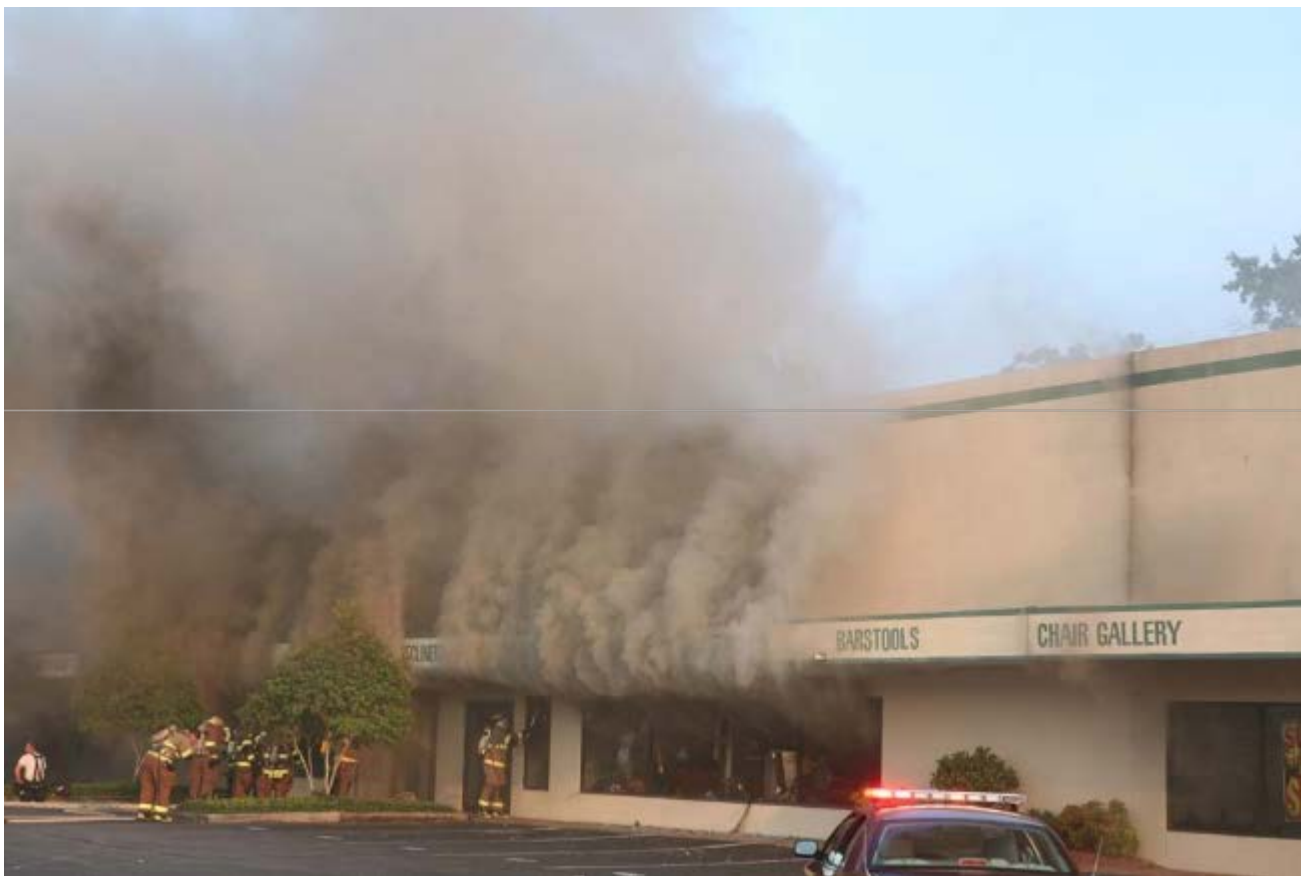
**Photo 6. Time approximately 1936 hours. Note turbulent dark gray smoke rolling out of the showroom as the front windows are being knocked out. Mutual aid crew is assembling for search and rescue attempt. (Photo courtesy of Associated Press, Alexander Fox, photographer.)**

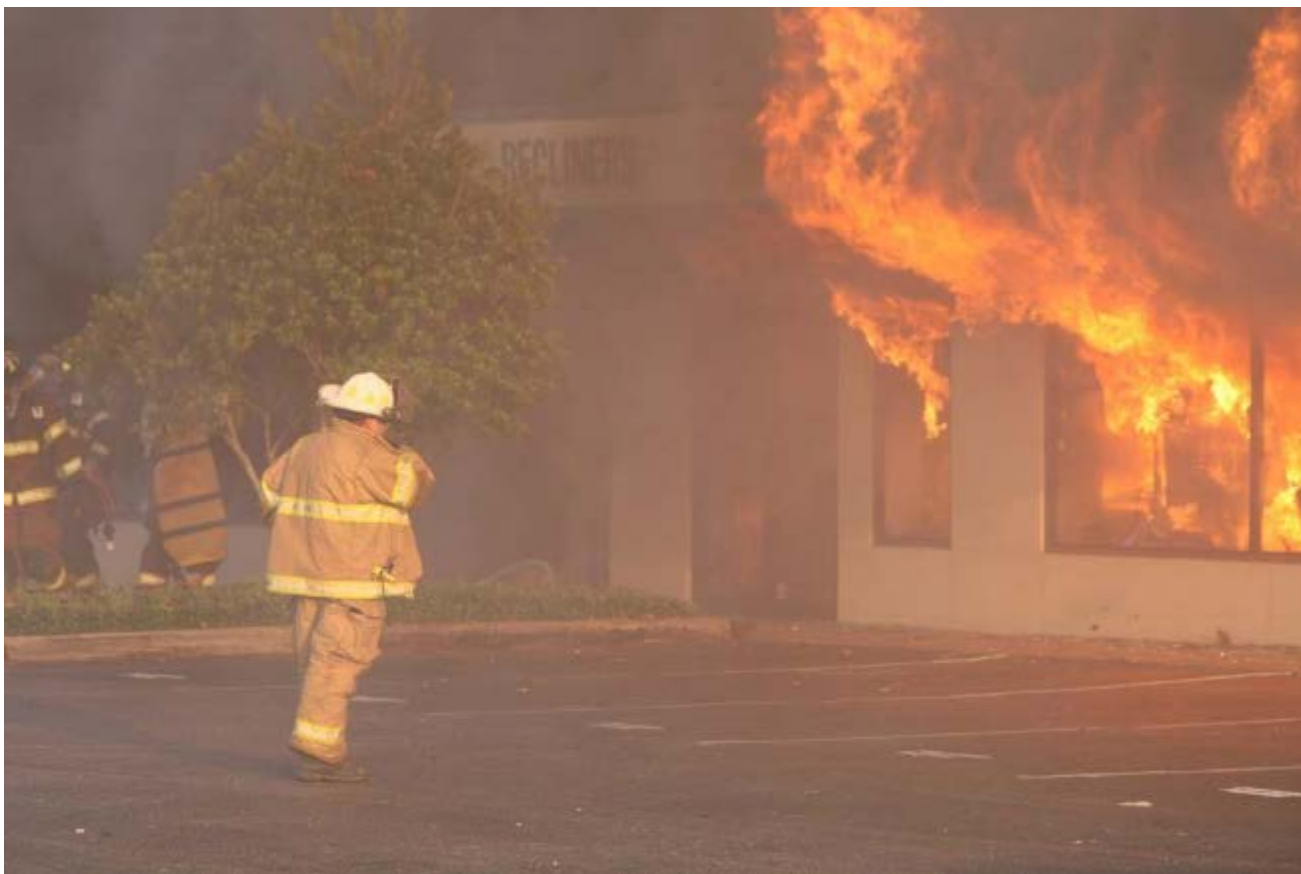
**Photo 7. Time approximately 1938 hours. Photo shows conditions at front of showroom just before the interior search and rescue attempts were halted due to the interior conditions.**  
*(Photo courtesy of the Charleston Post and Courier.)*

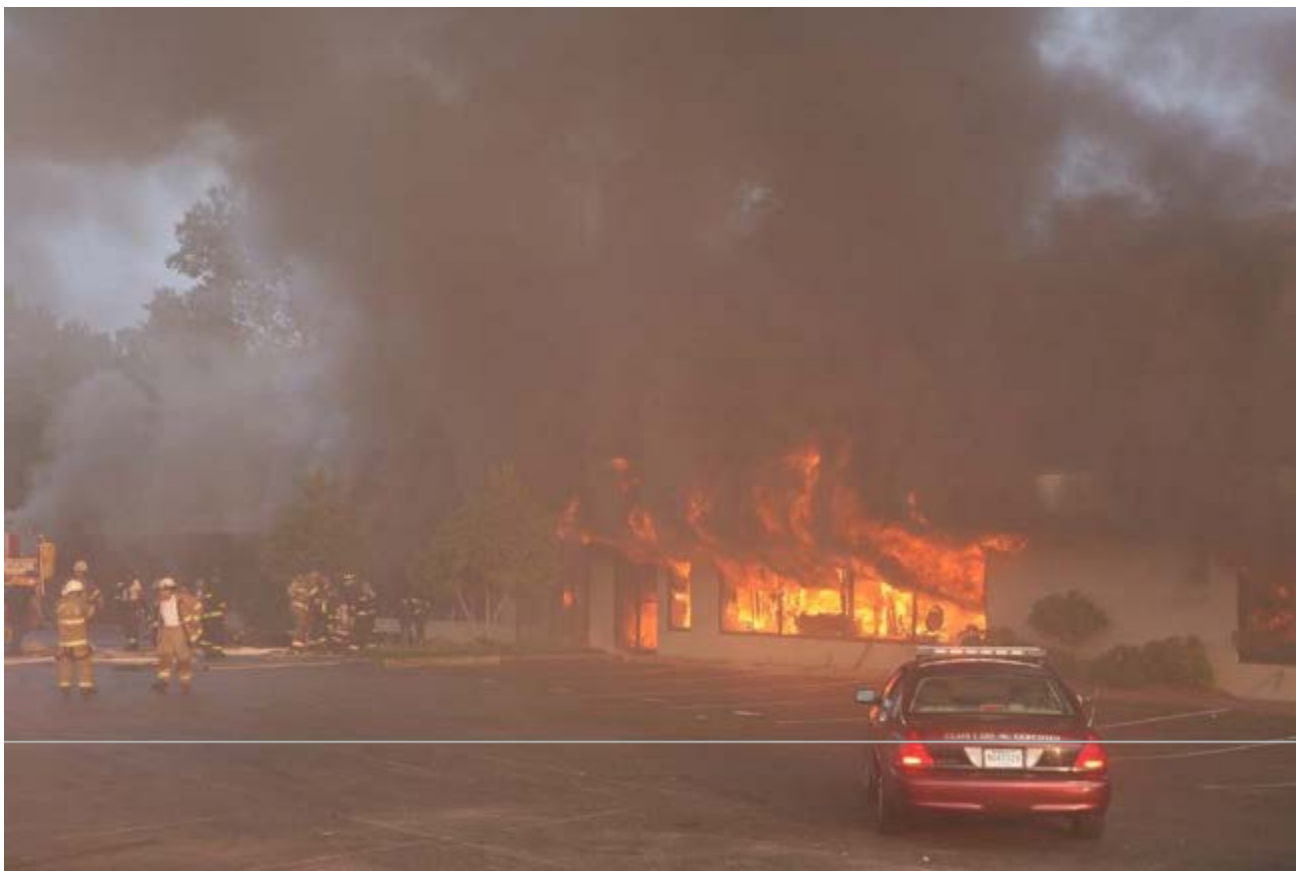
**Photo 8. Time approximately 1938 hours. Photo taken less than a minute after rescue crews are forced out of the showroom by the interior conditions. Note fire rolling out the showroom windows. (Photo courtesy of the Charleston Post and Courier.)**

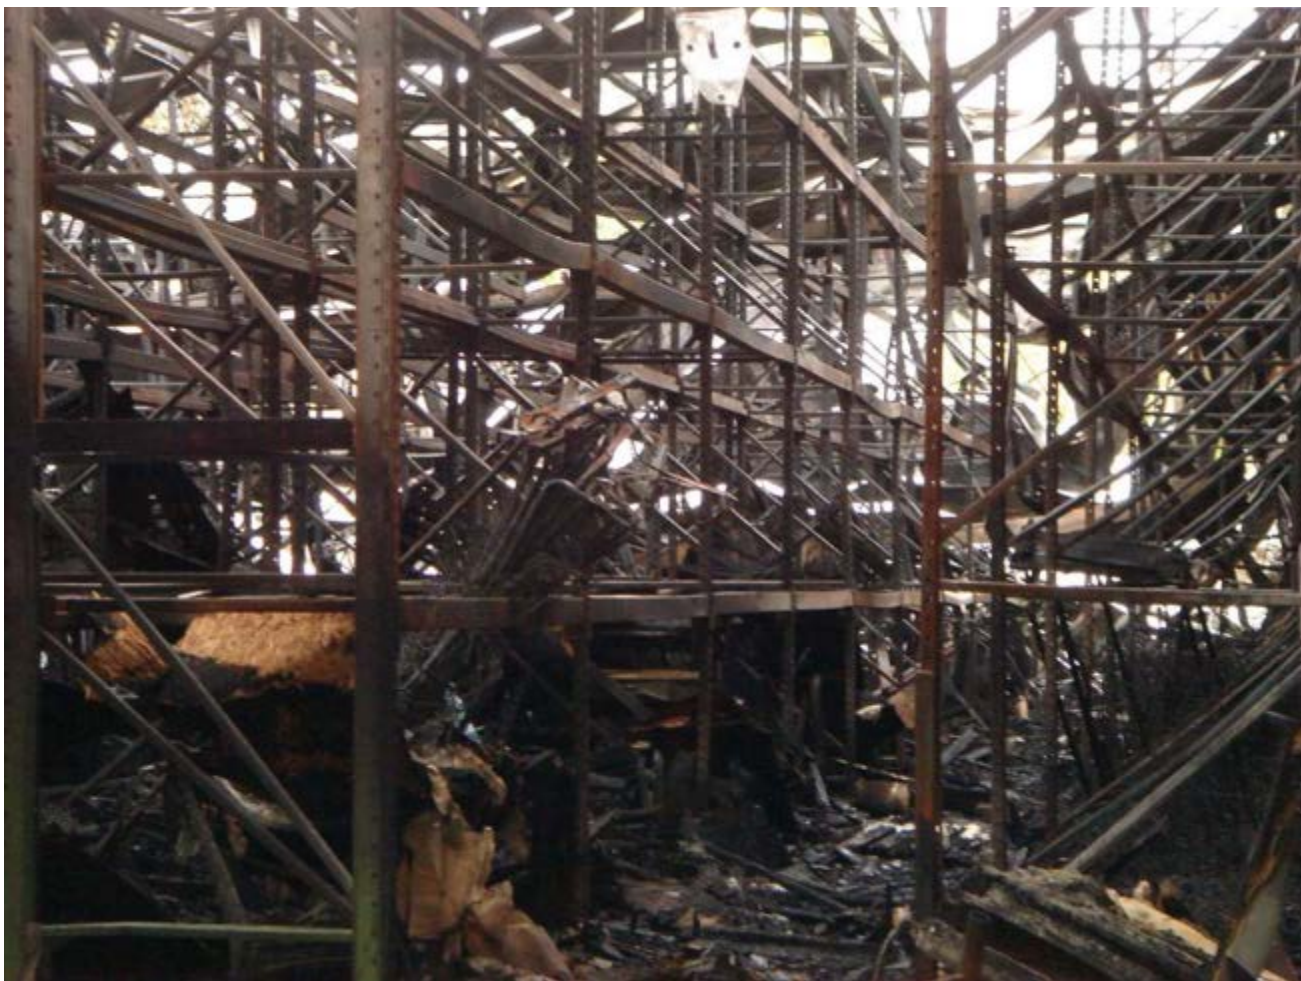
**Photo 9. Storage racks in warehouse post fire. Storage racks were filled with various furniture and mattress items. Note the extent to which the storage racks filled the warehouse which gives an indication of the volume of merchandise and the fuel load inside the 15,600 square foot warehouse. The warehouse measured approximately 130 ft. by 120 ft. and was 29 ft from floor to roof. (Photo – NIOSH.)**

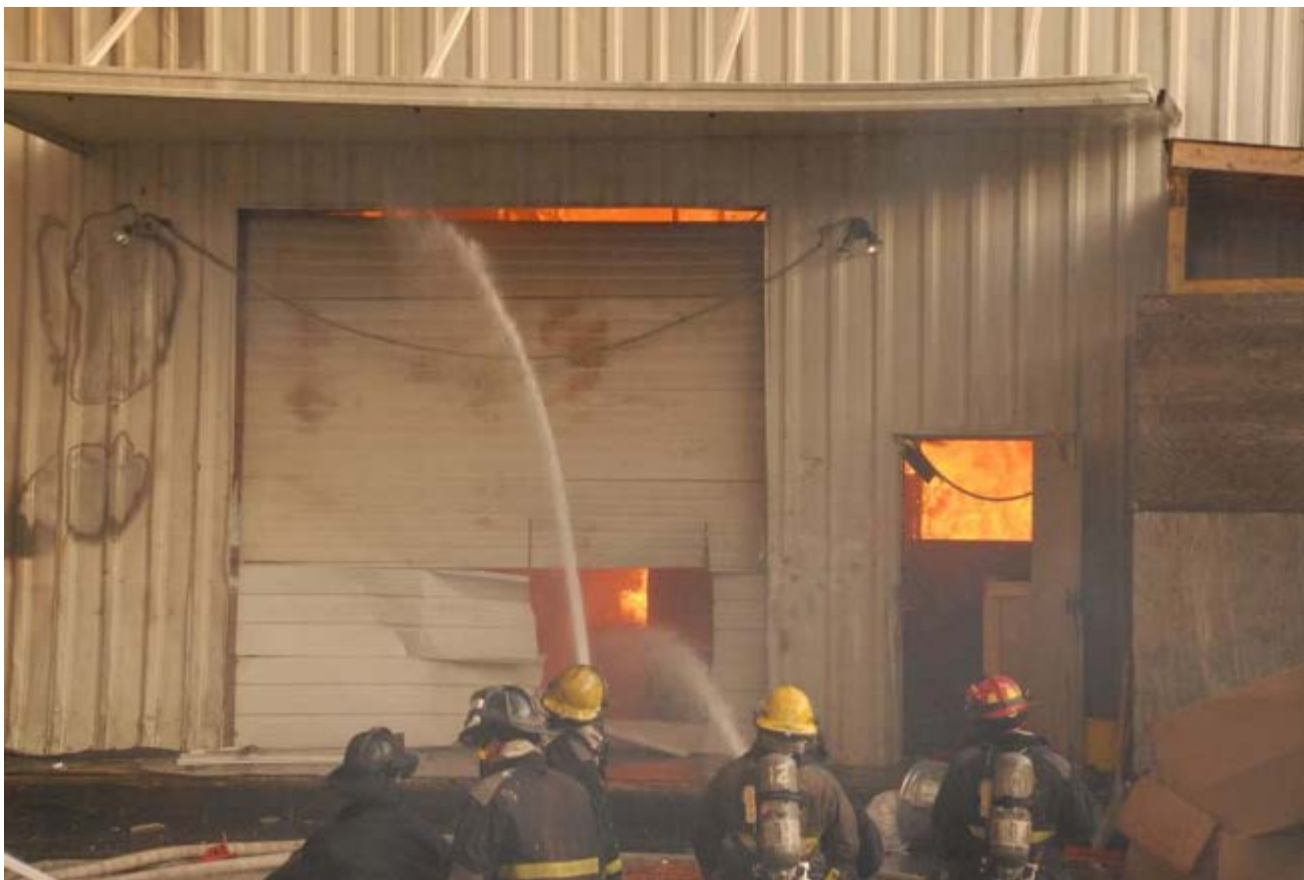
**Photo 10. Time approximately 1942 hours. Engine 10 and Engine 12 crews battle fire in warehouse from outside. (Photo courtesy of police department, Bill Murton, photographer.)**

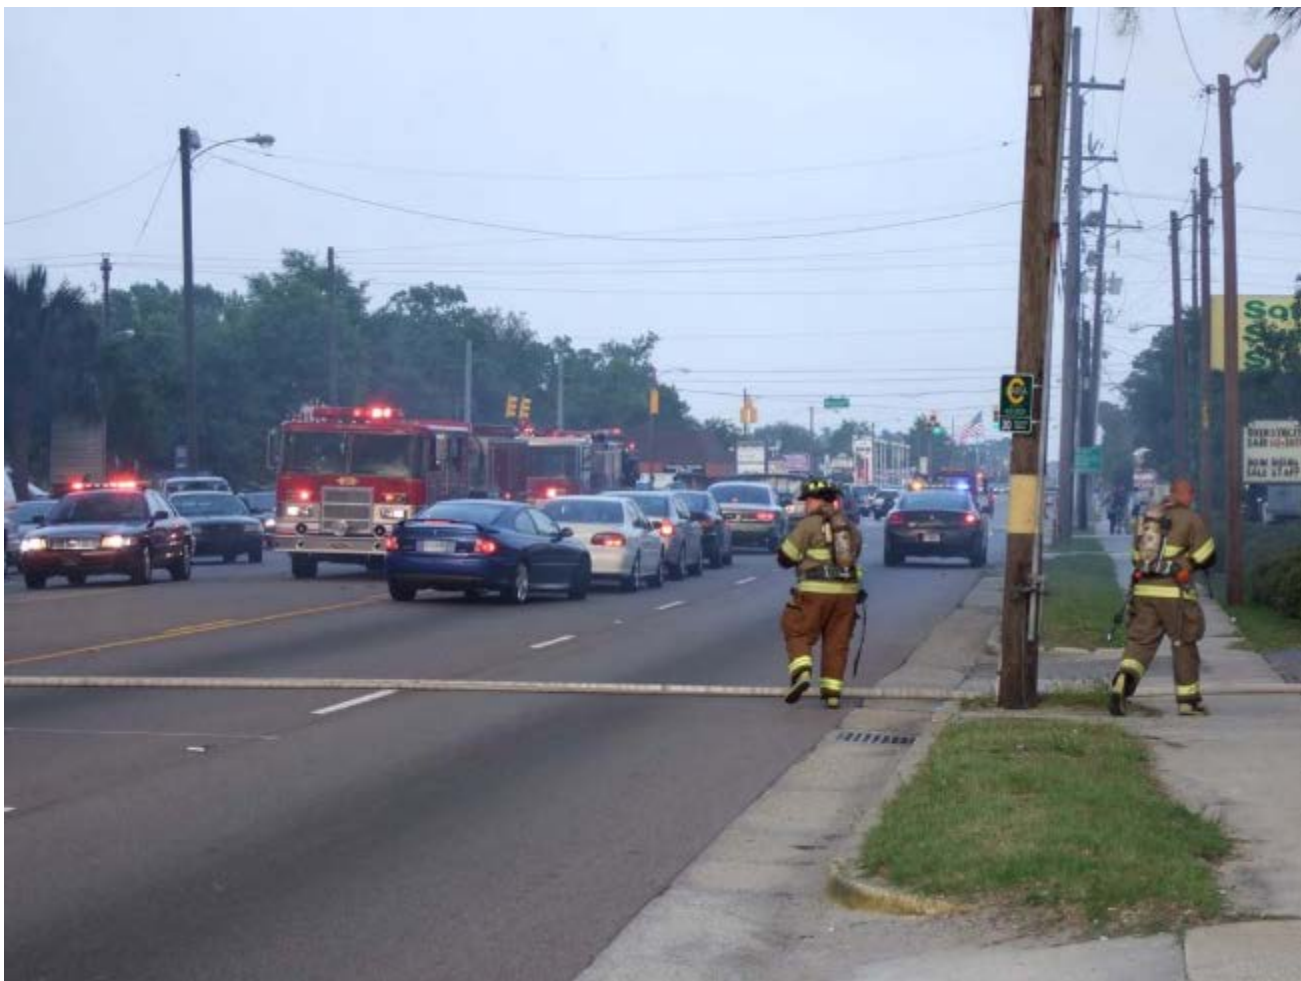
**Photo 11. Time approximately 1925 hours. Note traffic on major highway in front of incident site driving over 2 ½ inch supply line. The hoseline runs from Engine 12 (to left of photo) to Engine 10 (to right of photo. Photo shows mutual aid crew members arriving on scene. (Photo courtesy of Dan Folk.)**

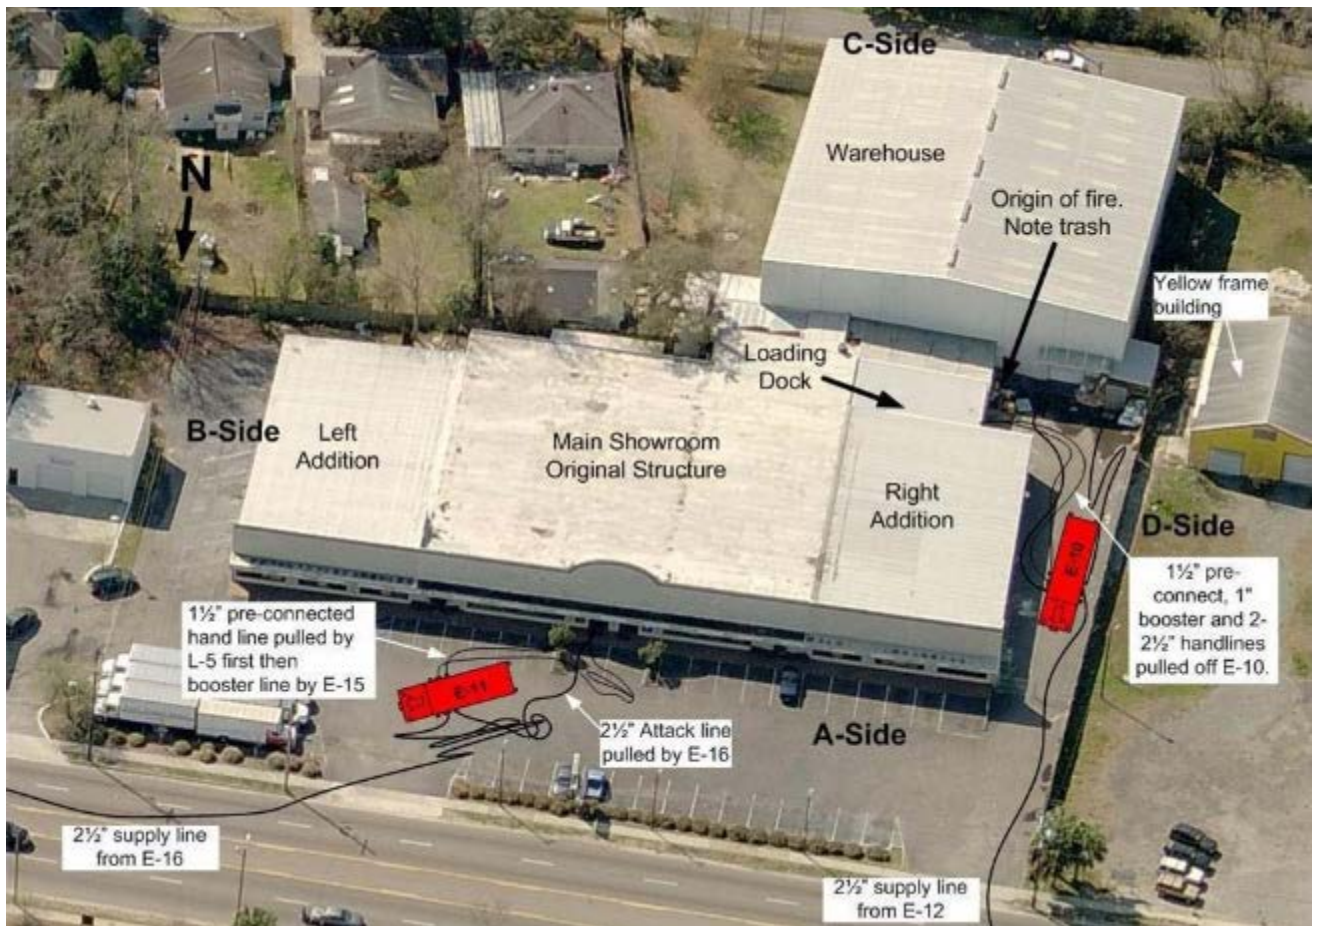
**Diagram 2. Location of Engine 10 and Engine 11, supply lines and hoselines pulled at different times during the incident. Note accumulation of trash at loading dock on the day photo was taken, 3 months prior to the incident. Note the absence of ventilation ductworks or other roof penetrations over the showroom, thus no path for smoke and hot gases to escape. From aerial photo taken in March 2007 (copyright Pictometry International – used with permission of Pictometry)**

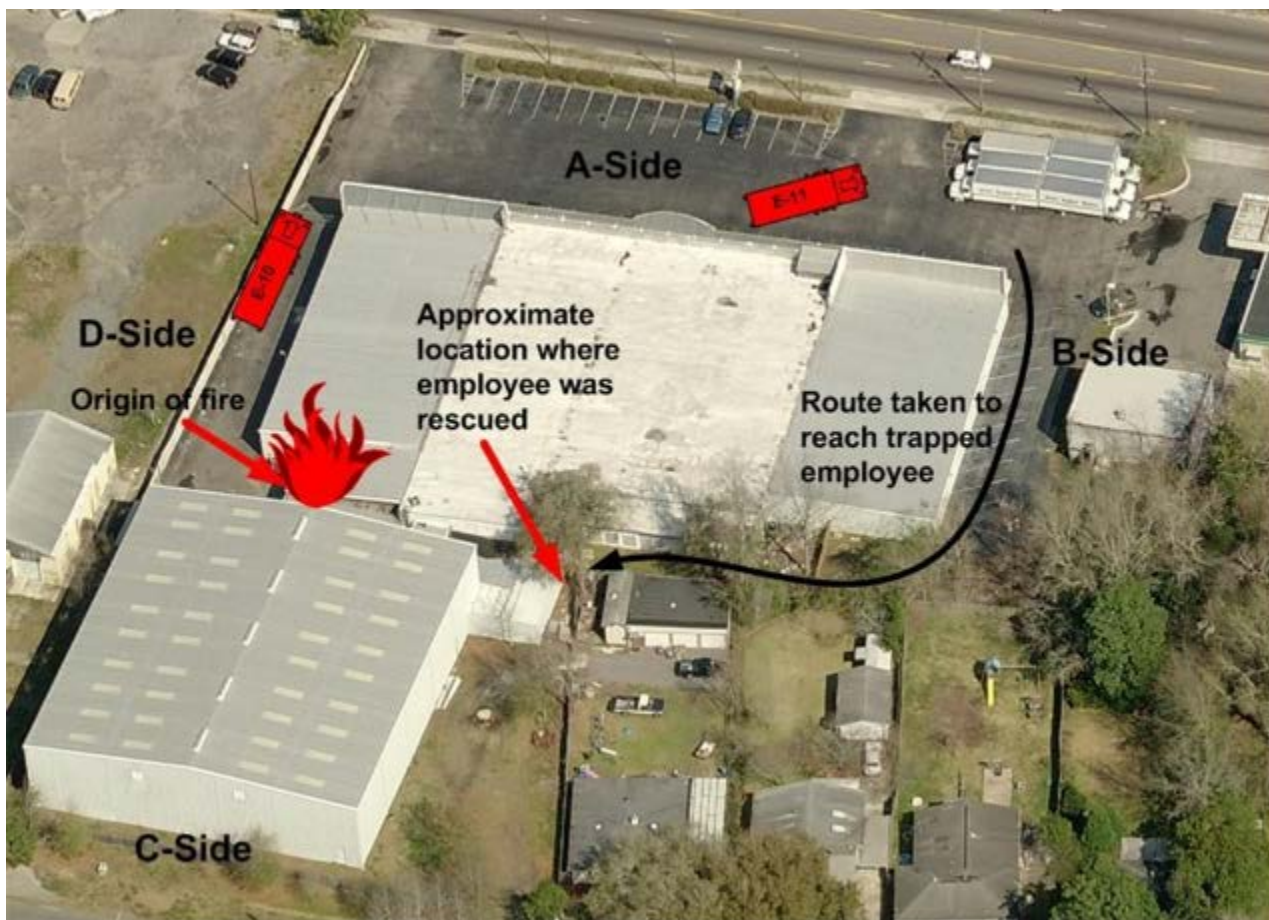
**Diagram 3: Note location where mutual aid crew cut through exterior wall to extricate male employee trapped inside the warehouse. From aerial photo taken in 2007.**

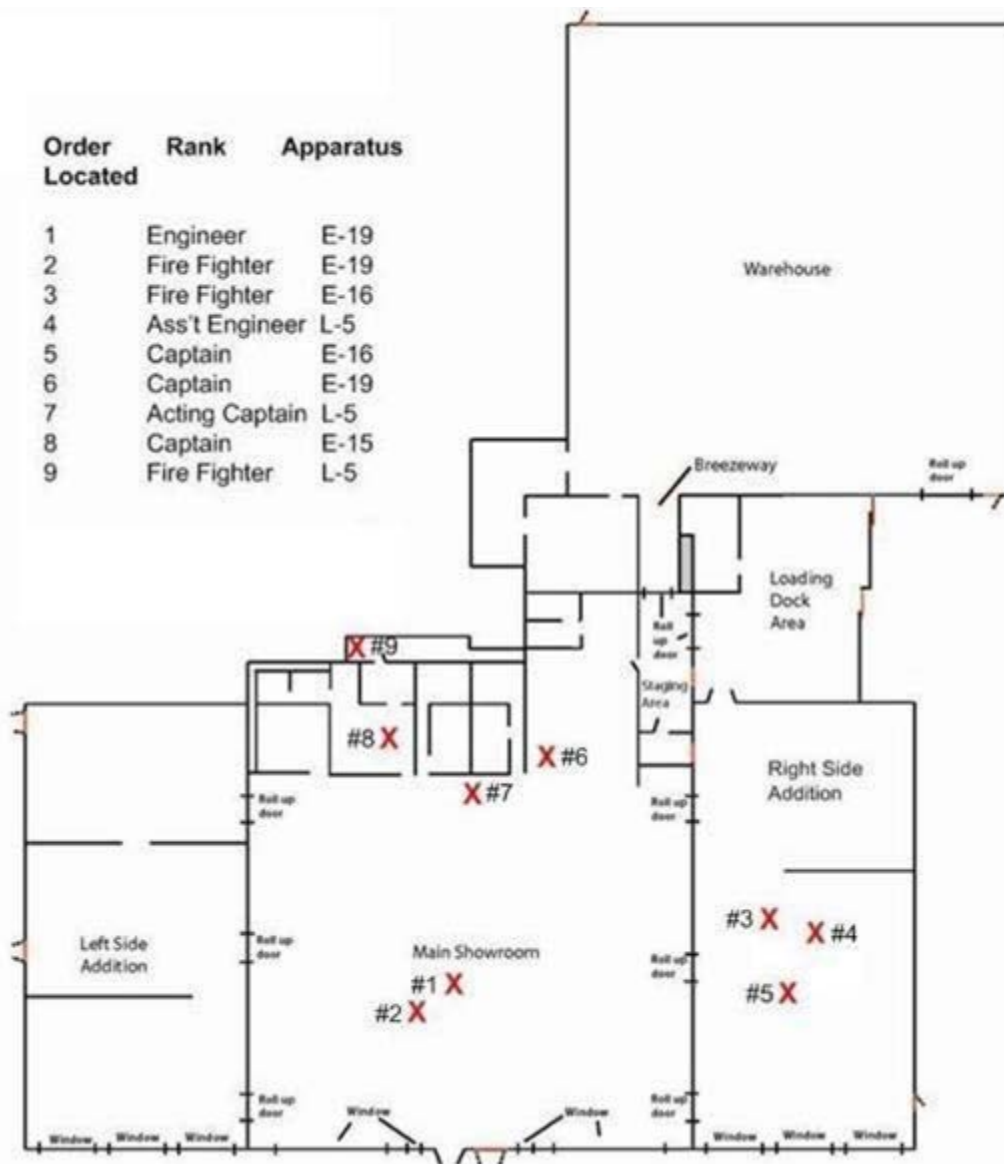
**Diagram 4. Approximate Location of 9 Victims. Victims 1, 2, 6 and 7 are located in the Main showroom. Victims 3, 4, and 5 are located in the Right Side Addition. Victims 8 and 9 are located behind the main Showroom.**

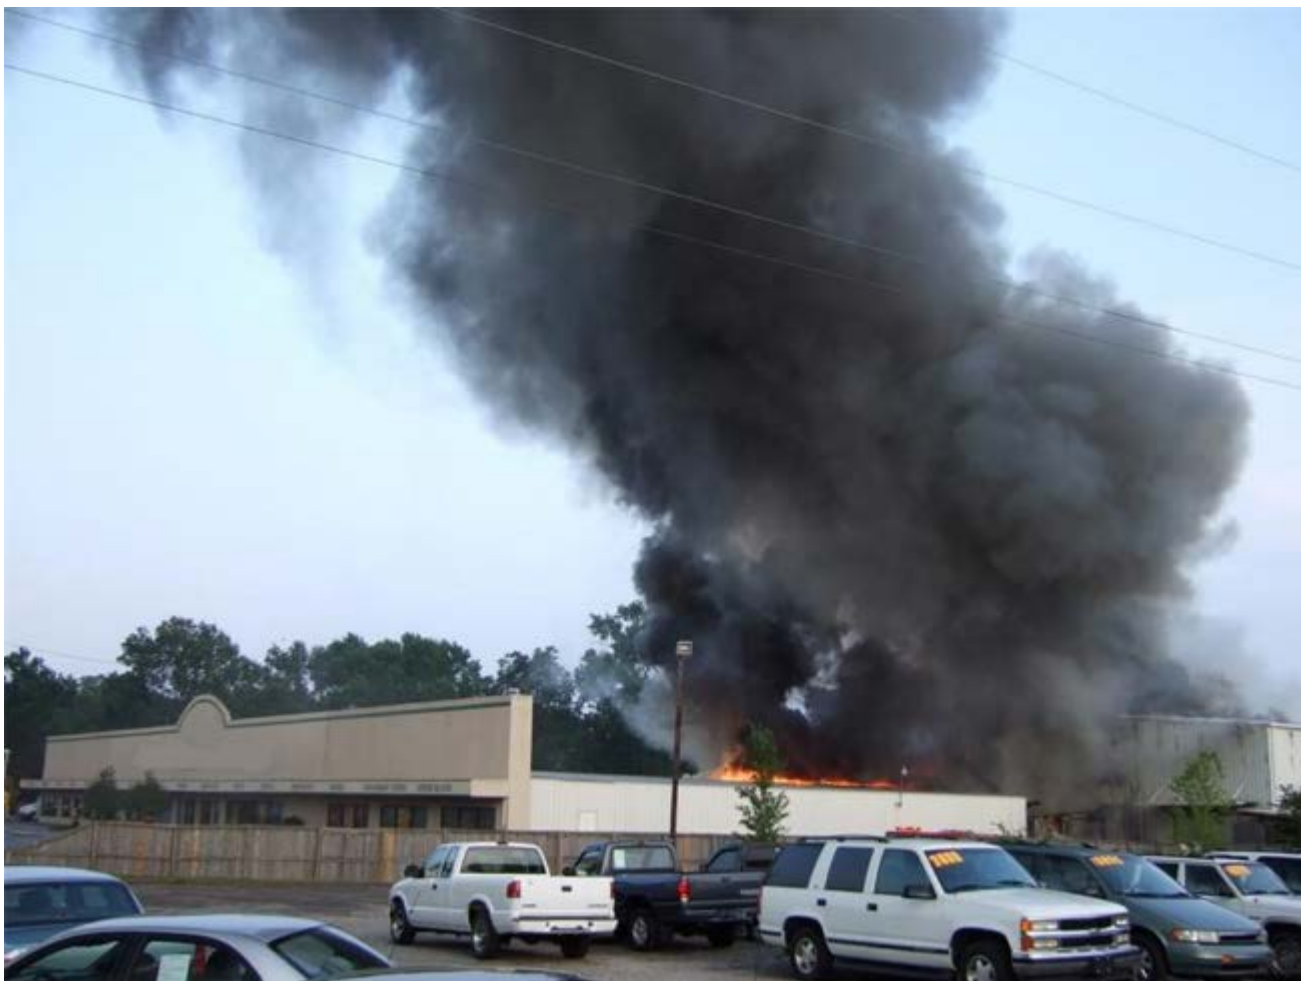
**Photo A-1. Time is approximately 1923 hours. Fire is visible over showroom roof. Smoke is dark gray in color and becoming turbulent. The flames may not have been visible from front parking lot or close to the building on the D-side. (Photo courtesy of Dan Folk.)**

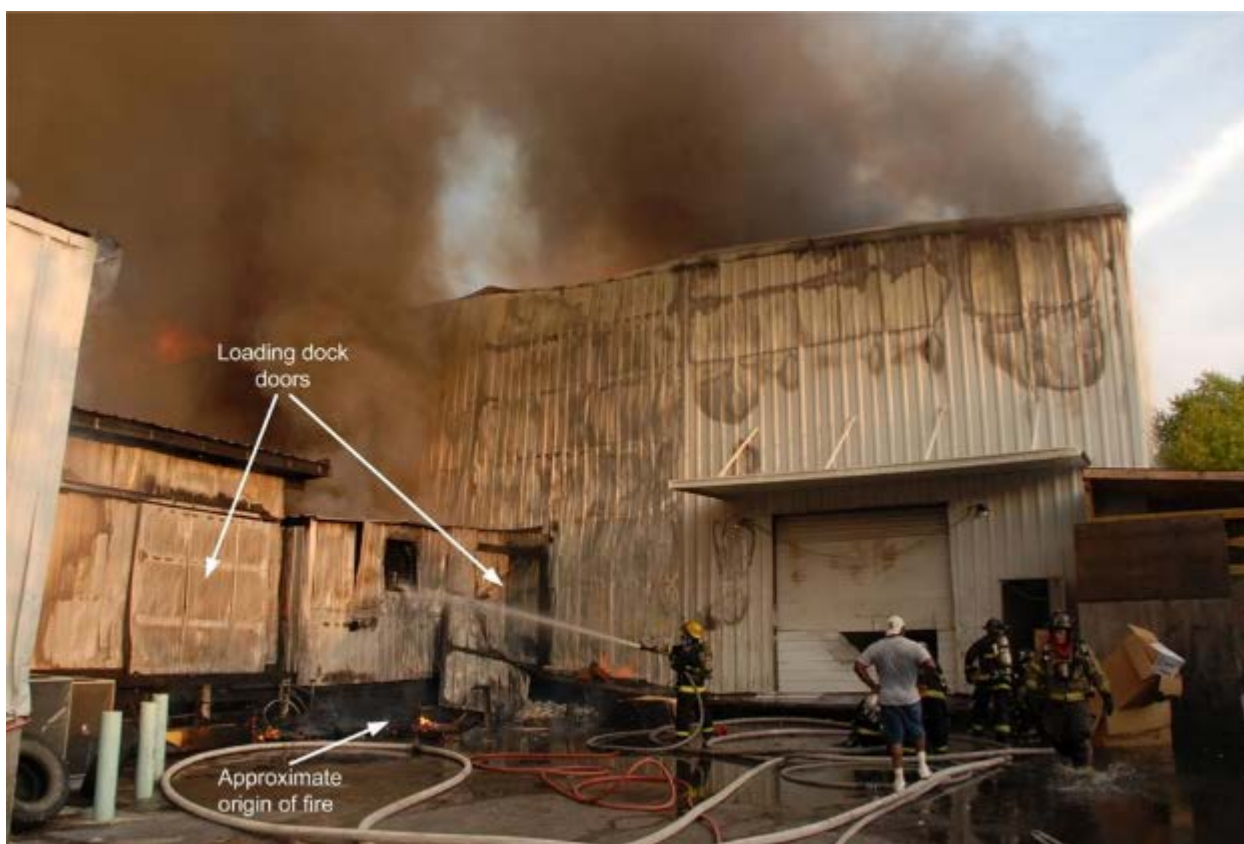
**Photo A-2. Time is approximately 1936 hours. Loading dock area approximately 20 minutes after first crews arrived on scene. There is heat damage to metal siding on loading dock and warehouse. There are two Loading dock doors. There is an approximate origin of fire in the corner. (Photo courtesy of Police Department, Bill Murton, photographer.)**

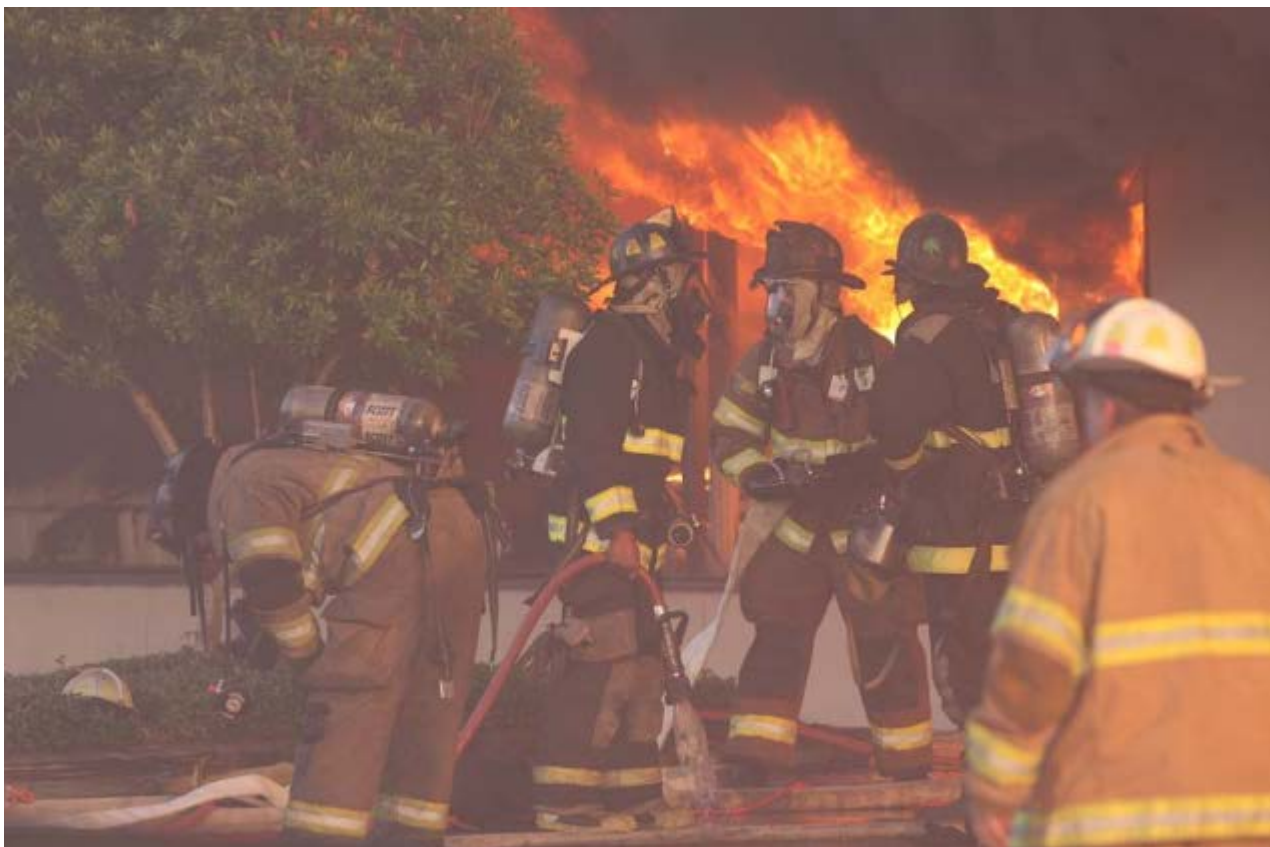
**Photo A-3. Time approximately 1939 hours. Fire fighters near front entrance to showroom. Note lack of water pressure on the red booster line and the 2 1/2" hand line. Also note lack of gloves and hood. (Photo courtesy of the Charleston Post and Courier.)**

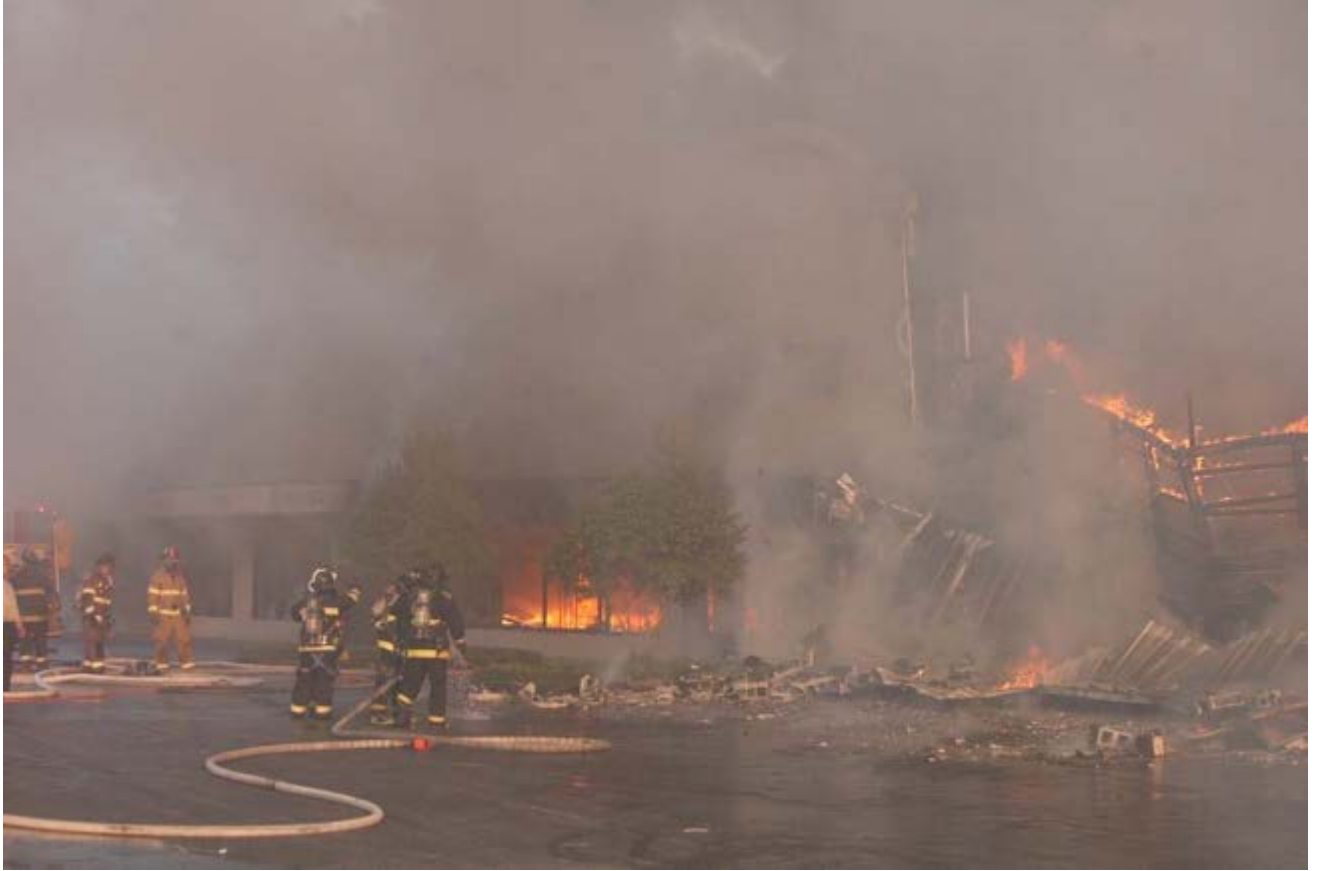
**Photo A-4: Time approximately 1951 hours. Front façade beginning to collapse.** *(Photo courtesy of the Charleston Post and Courier.)*
