**Nine Career Fire Fighters Die in Rapid Fire Progression at Commercial Furniture Showroom — South Carolina**

Fire Fighter Fatality Investigation and Prevention Program

*A summary of a NIOSH fire fighter fatality investigation*

February 11, 2009

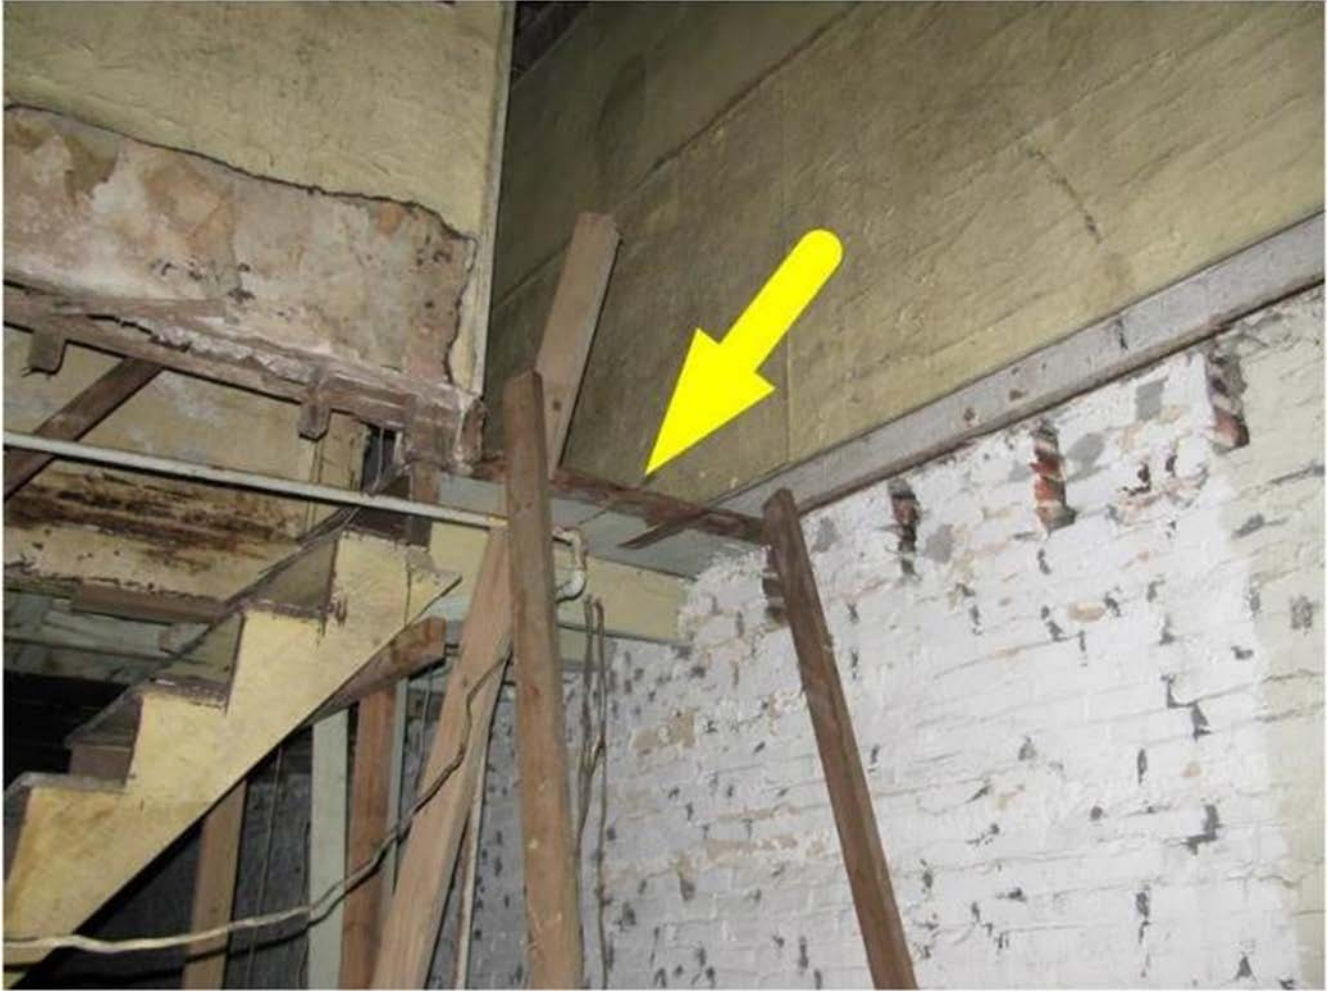
**Photo 4. View of the missing floor taken from near the approximate location where the shift safety officer likely landed on the basement floor. It is believed he stepped off the first floor at the area highlighted by the arrow.**

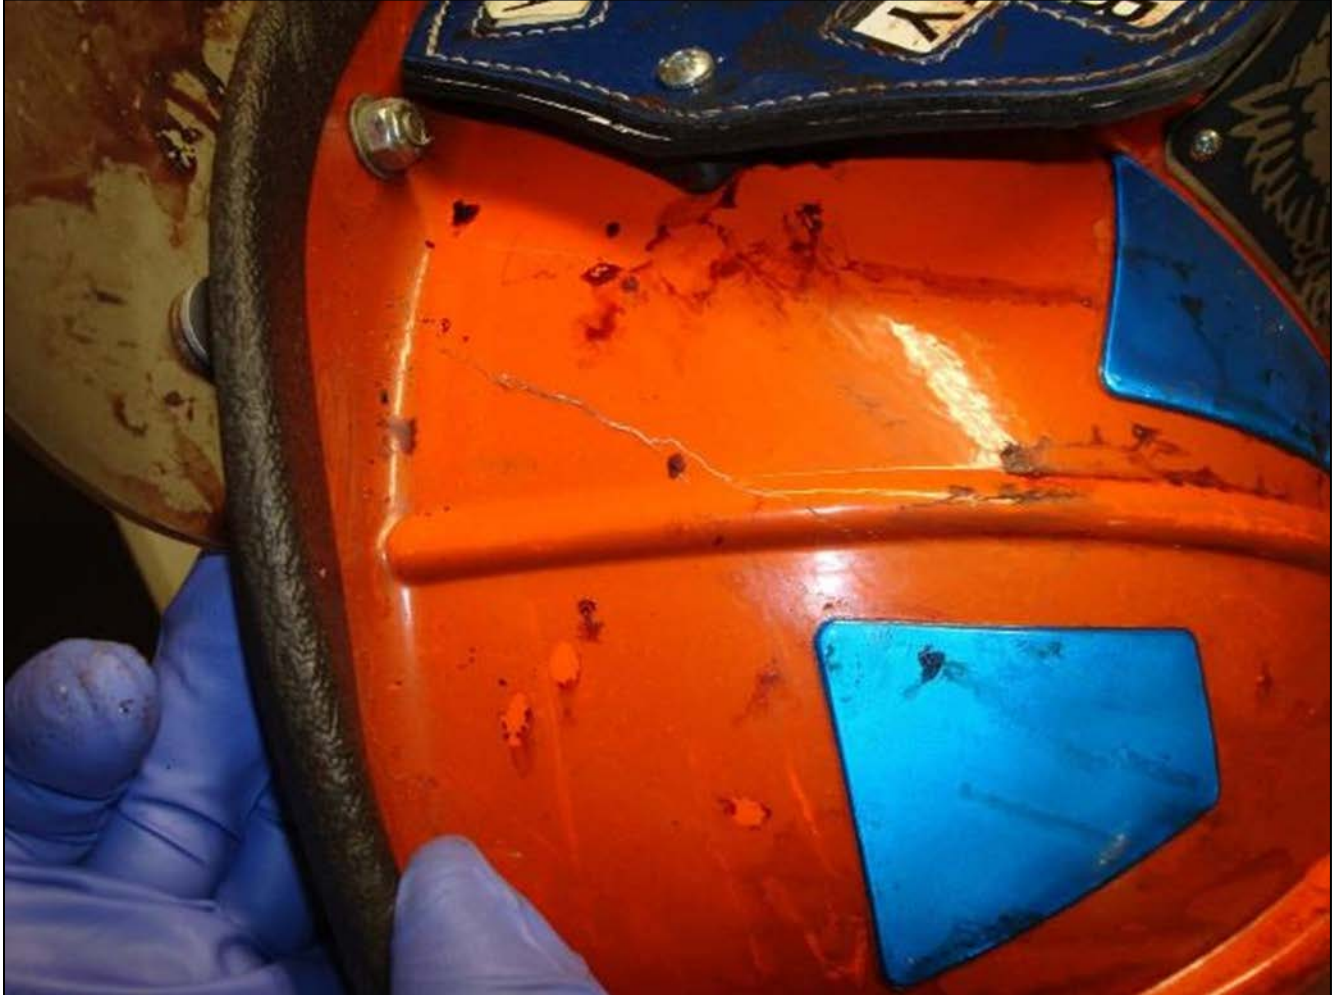
**Photo 6. Close up view of the shift safety officer's helmet. Note the crack in the helmet's outer shell near the center of the photo. Also note the blue tetrahedrons on the helmet and the blue shield. (Photo NIOSH)**

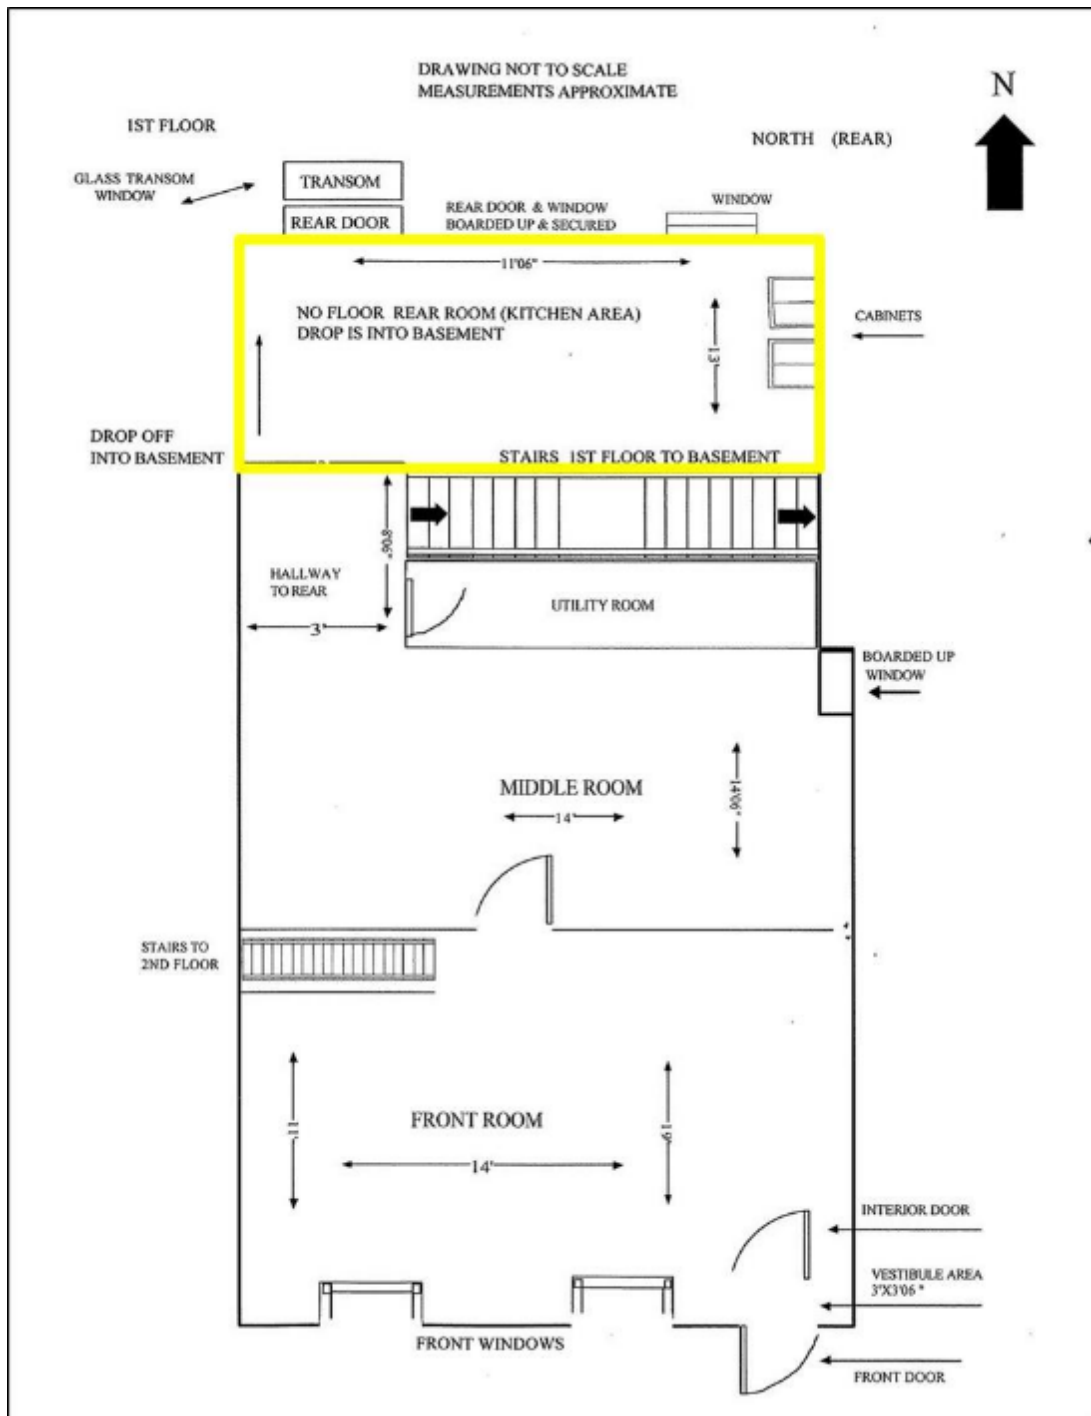
**Diagram 1. First floor layout of the Delta exposure where the shift safety officer was found. The highlighted area at the rear of the first floor is the area where all flooring and joists had been removed. (Adapted from drawing provided by Fire Department)**

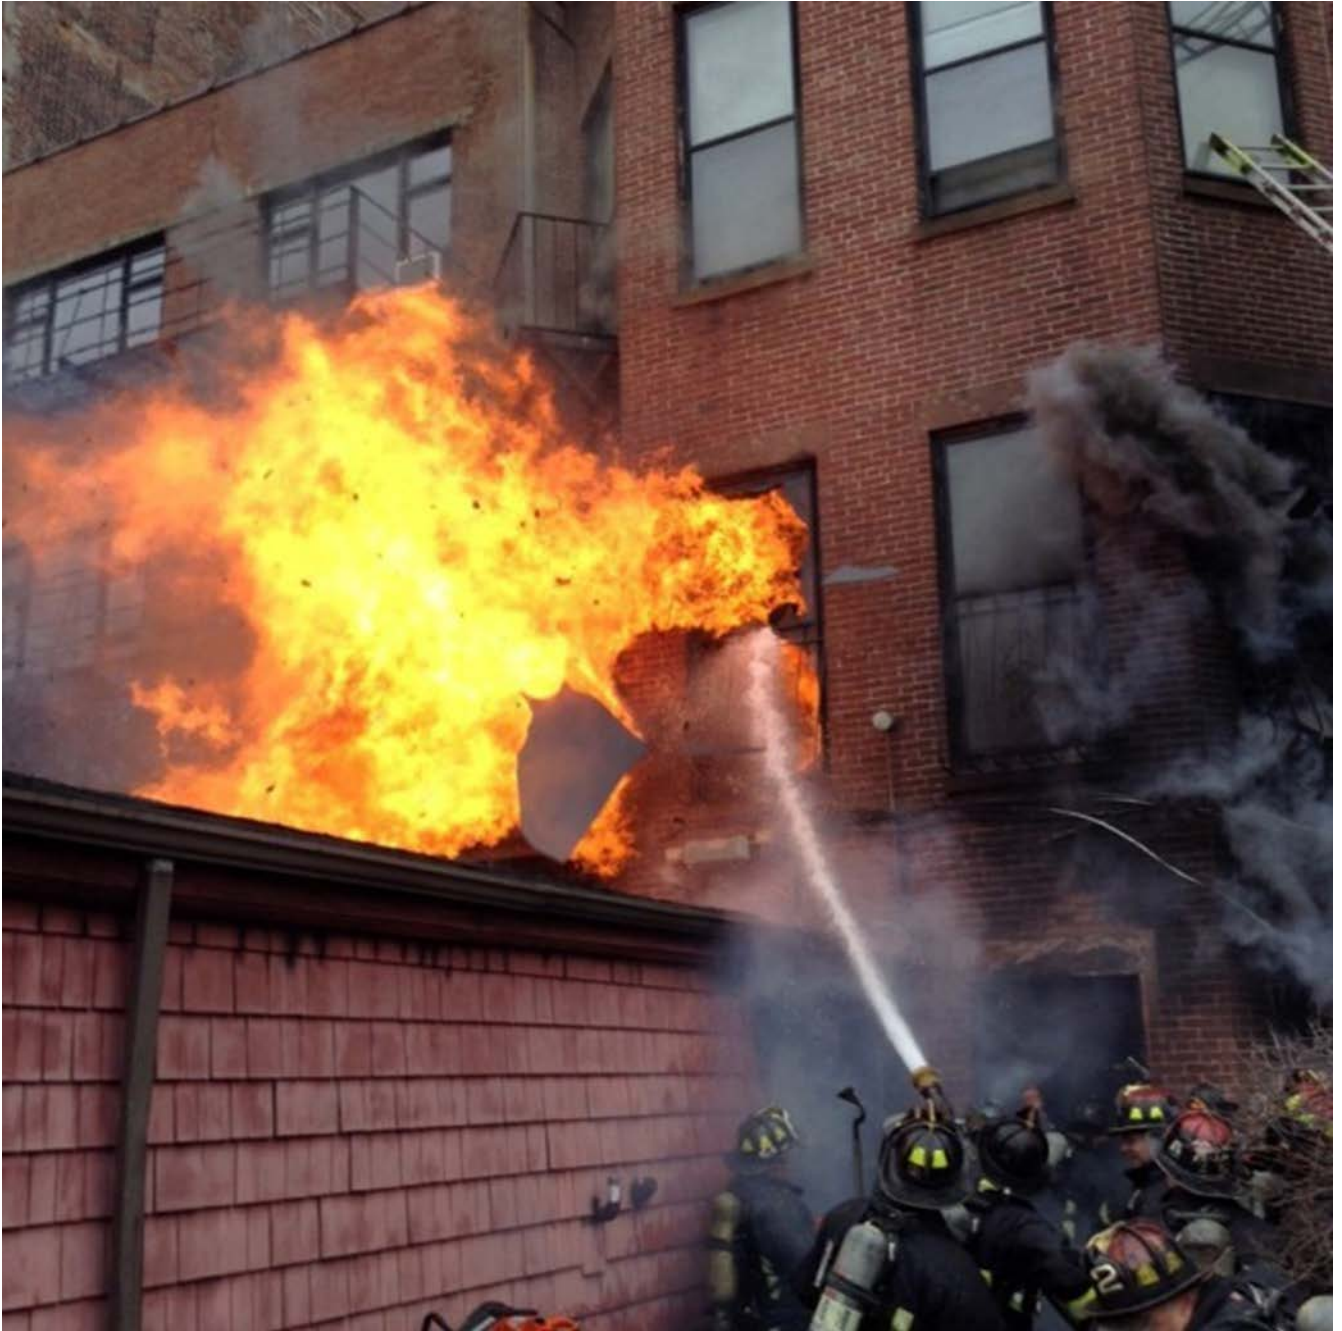
**Photo 3. A rapid progression of fire conditions occurred on the first floor at approximately 1511 hours. Crews were operating on Side Charlie (upwind side) and making entry into the rear basement apartment via the windows. This photo shows the force of the rapid progression of fire conditions. (Photo courtesy of the fire department.)**

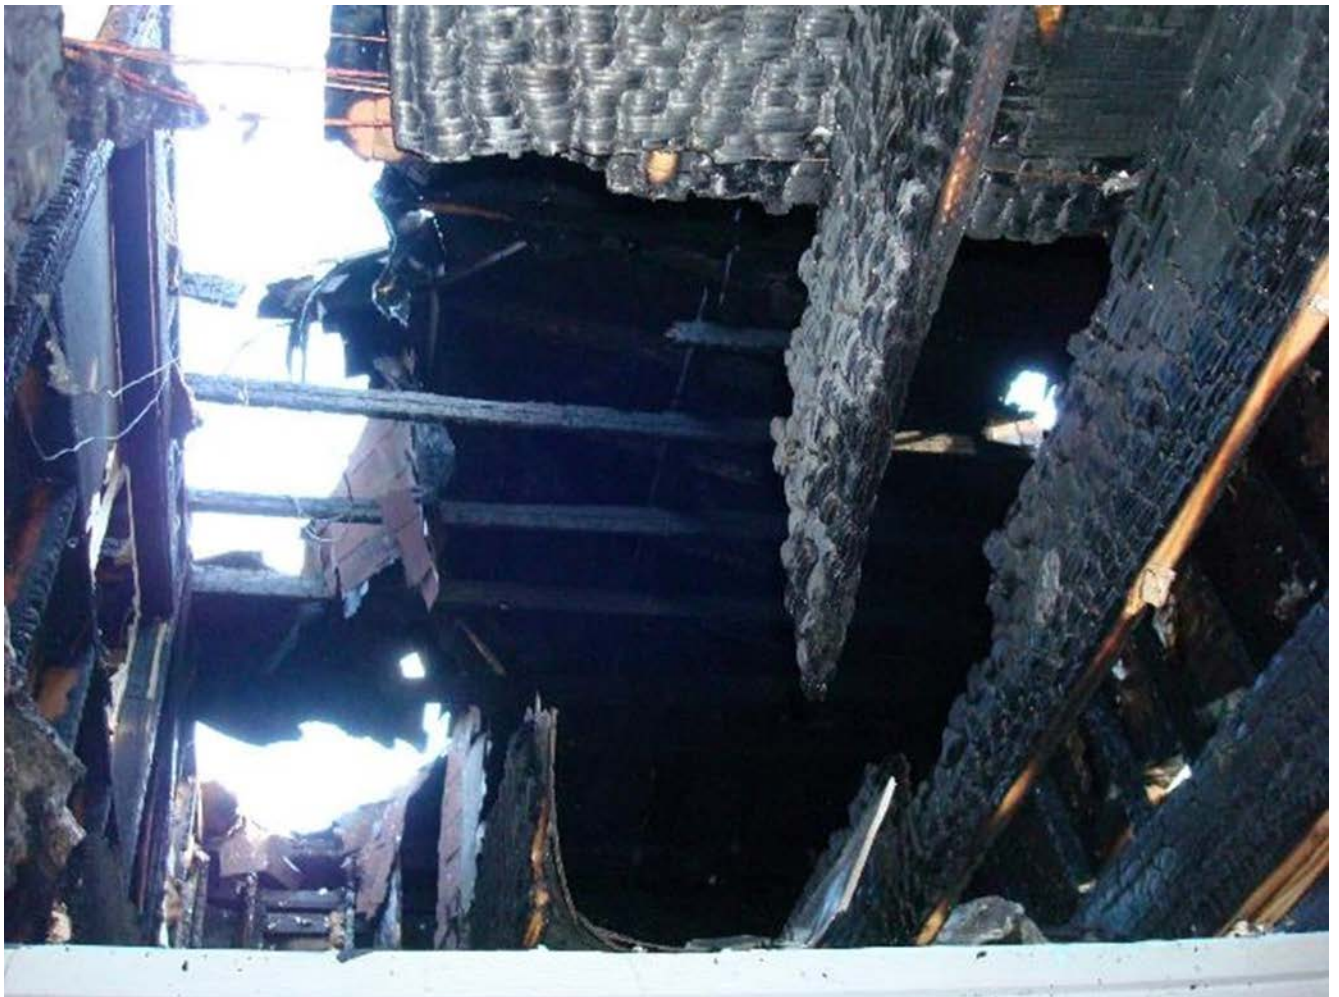
**Photo 4. Large void space over the garage at the Alpha/Delta corner connecting the L-shaped attic structure.**  
*(NIOSH photo.)*

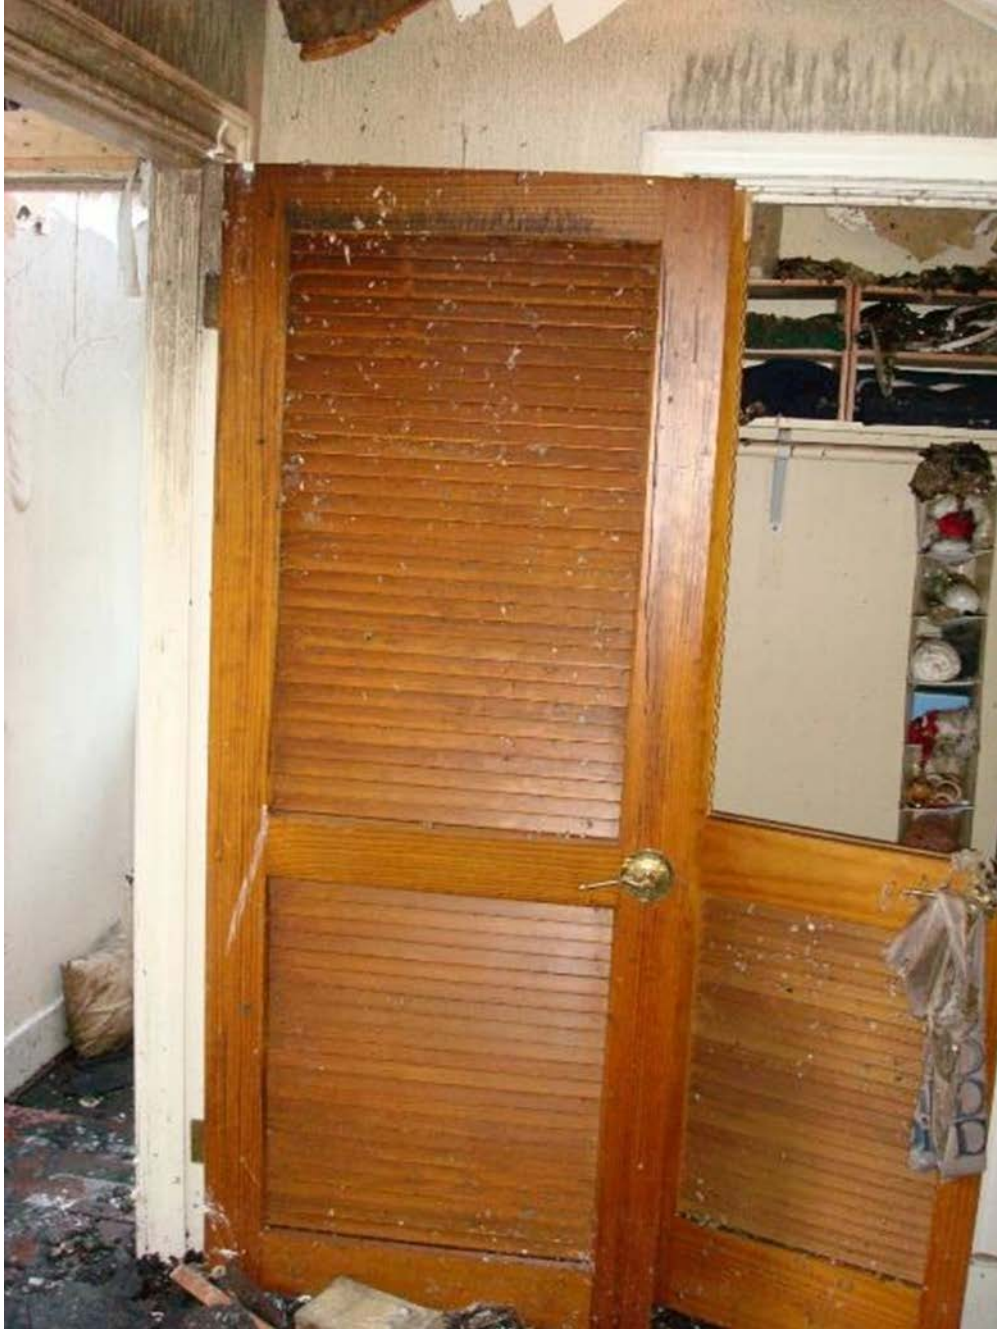
**Photo 5. Louvered door to sewing room at top of stairs to the left. Picture taken from inside the room. The top half of the louvered closet door (right) is broken out (see Possible scenarios, #2). (NIOSH photo.)**

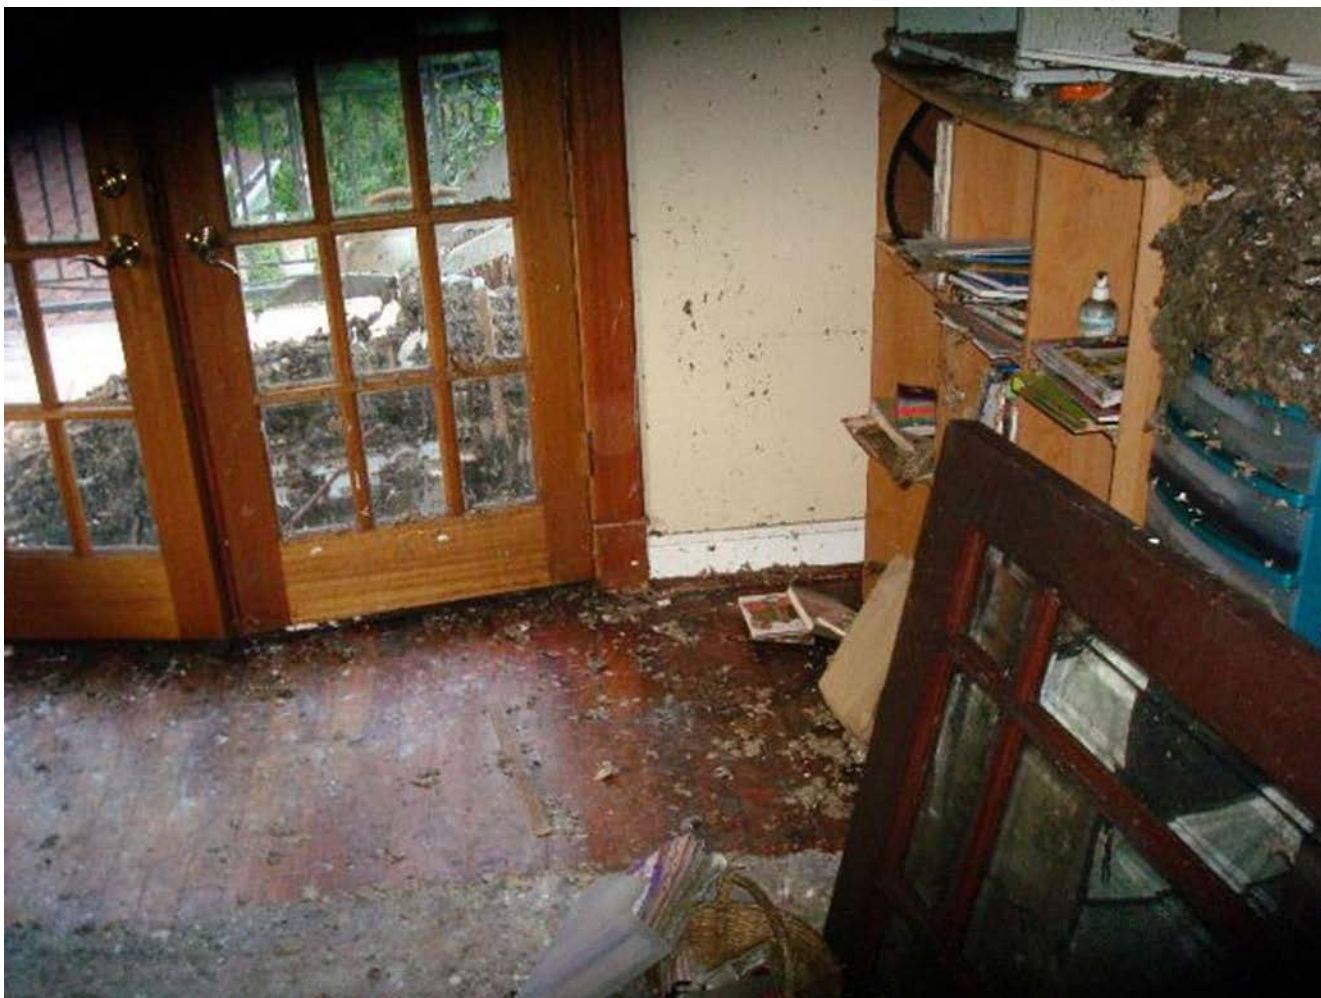
**Photo 6. The double glass panel doors of the sewing room that lead out to the second floor balcony. Note that the door handle on the right is a nonfunctioning handle and is bent down (see *Possible scenarios*, #3). FF1 was found on the floor at the base of the right panel door. (NIOSH photo.)**
