**Nine Career Fire Fighters Die in Rapid Fire Progression at Commercial Furniture Showroom — South Carolina**

Fire Fighter Fatality Investigation and Prevention Program

*A summary of a NIOSH fire fighter fatality investigation*

February 11, 2009

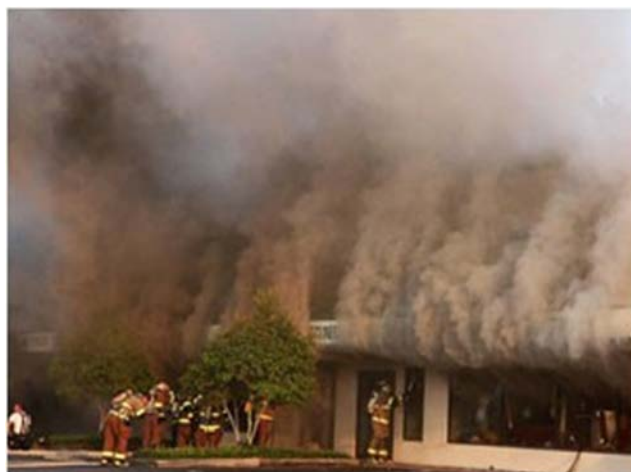
**Incident Scene**

He observed fire inside the structure when a *(Photo courtesy of Alexander Fox, Associated Press.)* door connecting the rear of the right showroom addition to the loading dock was opened. Within minutes, the fire rapidly spread into and above the main showroom, the right showroom addition, and the warehouse. The burning furniture quickly generated a huge amount of toxic and highly flammable gases along with soot and products of incomplete combustion that added to the fuel load. The fire overwhelmed the interior attack and the interior crews became disoriented when thick black smoke filled the showrooms from ceiling to floor. The interior fire fighters realized they were in trouble and began to radio for assistance as the heat intensified. One fire fighter activated the emergency button on his radio. The front showroom windows were knocked out and fire fighters, including a crew from a mutual-aid department, were sent inside to search for the missing fire fighters. Soon after, the flammable mixture of combustion by-products ignited, and fire raced through the main showroom. Interior fire fighters were caught in the rapid fire

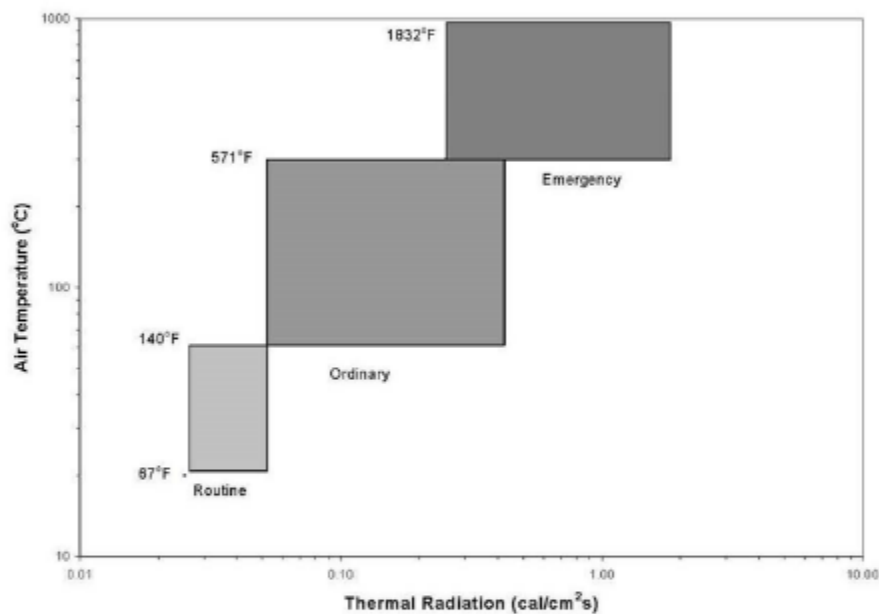
Figure 1— Classification of Fireground Conditions

The relationship between increasing thermal radiation (expressed in  $\text{cal/cm}^2\text{s}$ ) and the resulting rise in air temperature (expressed in degrees Celsius and degrees Fahrenheit) is presented in Figure 1. Possible structural fire fighting situations are illustrated in this figure:<sup>1,2</sup>

- The **Routine** region describes conditions where one or two objects, such as a bed or waste basket, are burning in a room. The thermal radiation and the air temperatures are virtually the same as those encountered on a hot summer day. As shown in Figure 161, **Routine** conditions are accompanied by a thermal radiation range of 0.025 to 0.05  $\text{cal/cm}^2\text{s}$  and by air temperatures ranging from 68 to 140°F. Protective clothing for fire

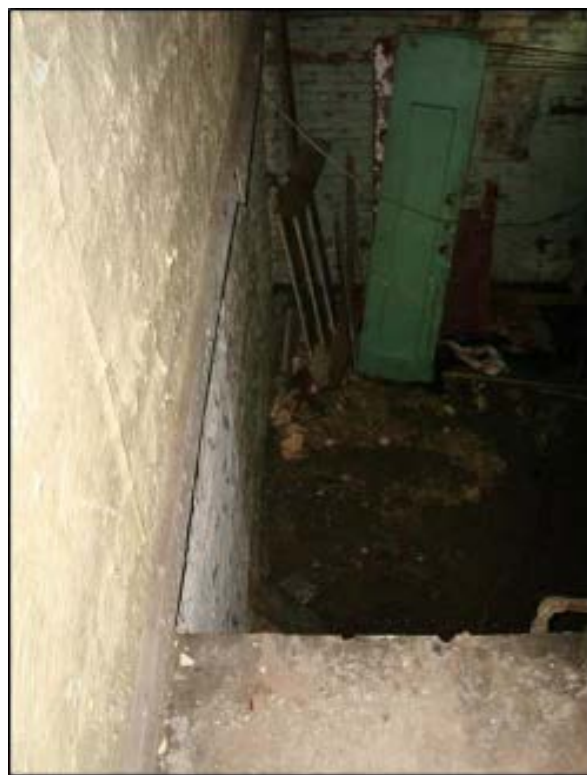
Crews working inside the Delta exposure observed that the ground-level floor at the rear of the structure had been completely removed but did not report this hazard to Incident Command when they exited. Hole in floor at rear of vacant row house. The shift safety officer entered the Delta exposure alone

**The victim fell approximately 7 feet onto** and apparently fell through the hole, receiving face and **the basement floor.** head injuries. All remaining personnel cleared the incident (*Photo*

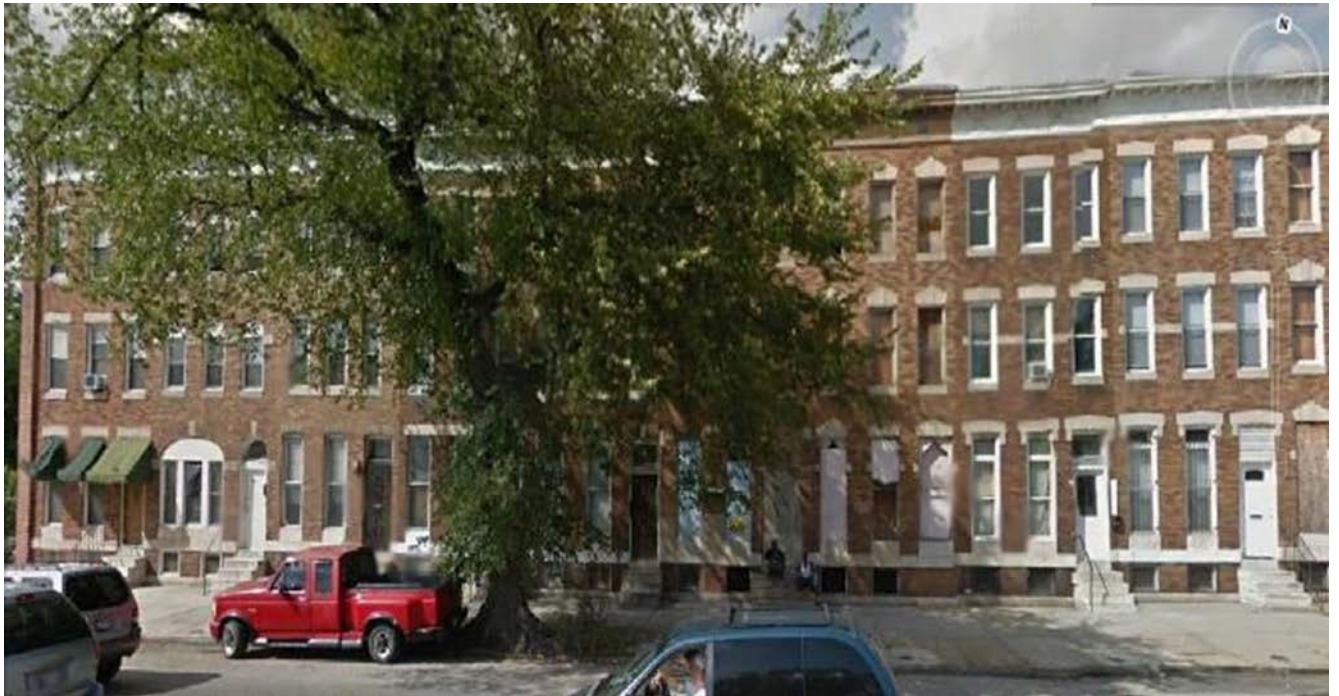
The row houses measured approximately 14 feet 2 inches wide by 55 feet long. Each row house had three stories above ground and a full basement partially below grade. Two small basement windows were located at street level in the front of each row house (see Photo 1 (entire block) and Photo 2 (close-up of basement windows)). The structure was located to the north of a major city street running east and west with two lanes of traffic in each direction plus a parking lane on the north side of the street.

**Photo 1. View of the city block where the incident occurred. Row houses fronting the entire city block are typical in this neighborhood.**

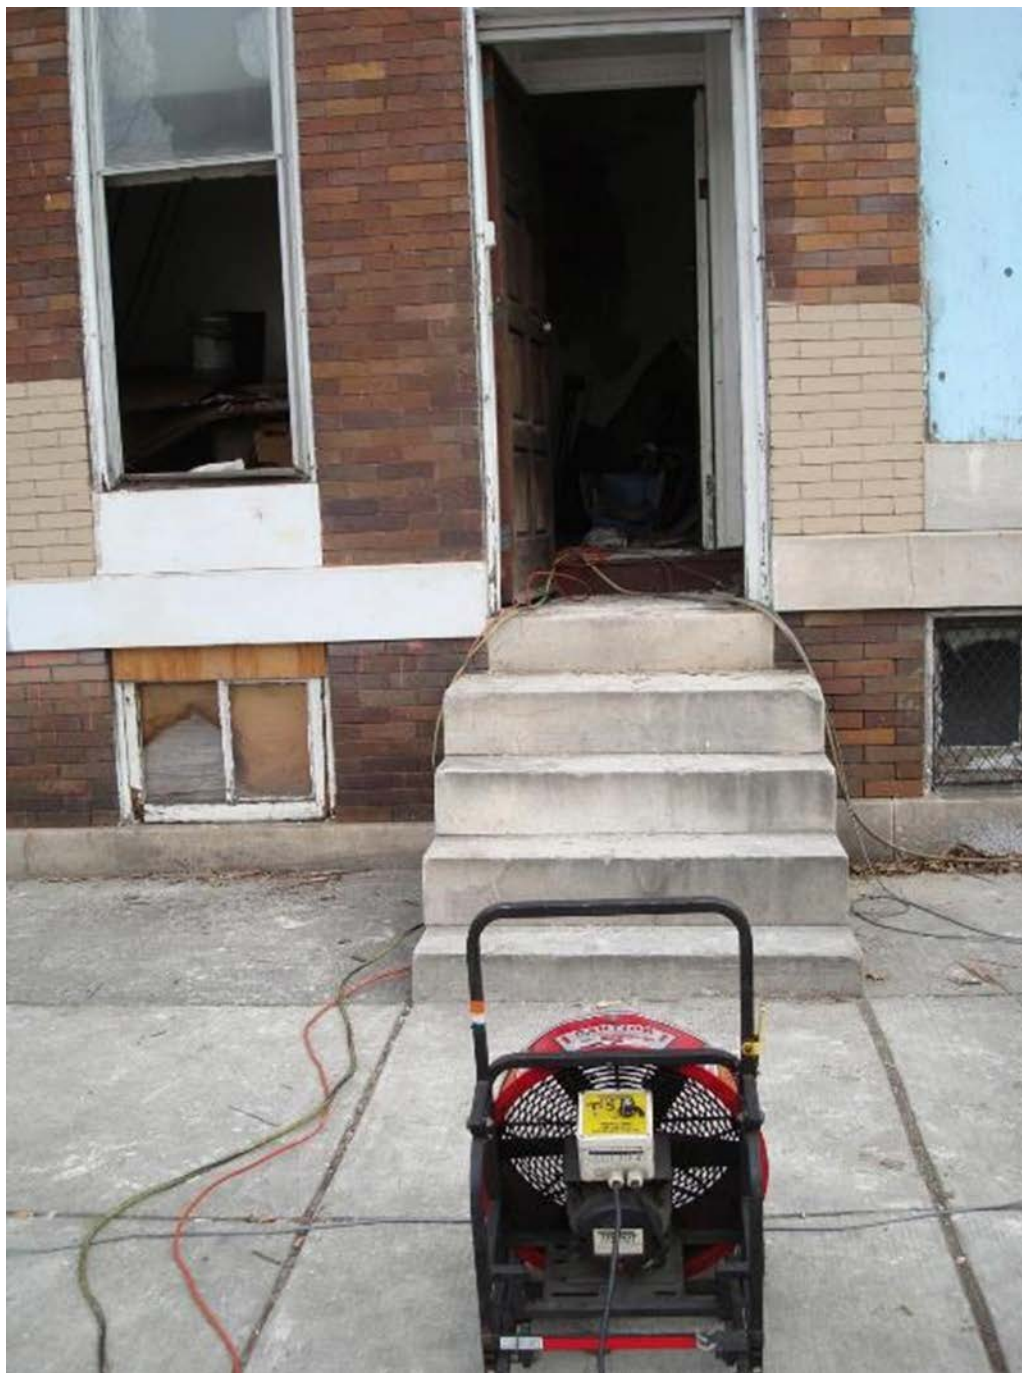
**Photo 2. View of the front door to the Delta exposure building. Note the small basement windows on both sides of the steps. Also note that this photo was taken during post-incident flow path testing by NIST (*Photo NIOSH*)**

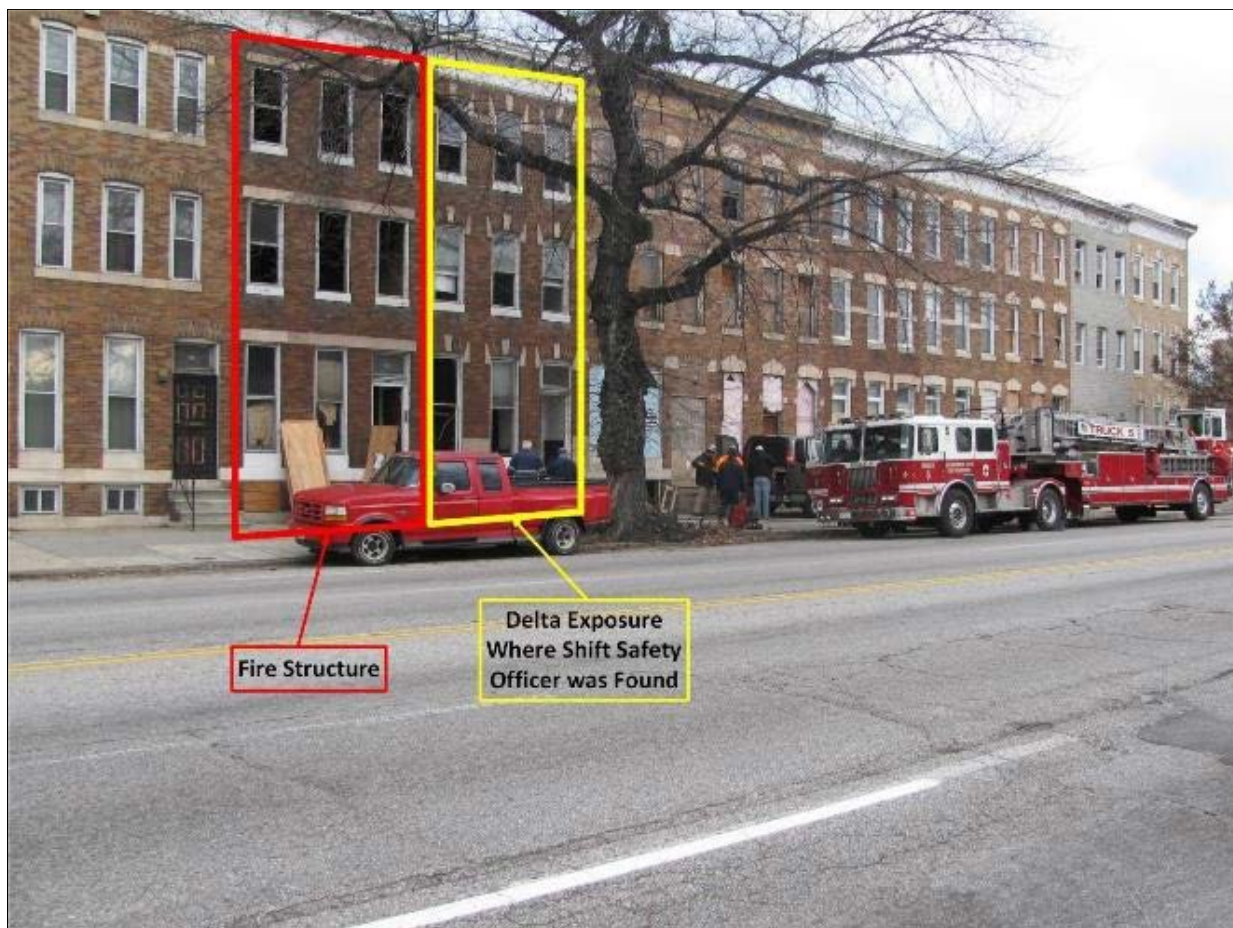
Photo 3 shows the orientation of the fire structure in the middle of the row. The shift safety officer was found in the Delta exposure. At some point, the side Delta exposure had undergone some refurbishment work. The complete floor system had been partially removed at the rear of the first (ground level) floor. All the floor boards and floor joists had been removed between the two common side walls, leaving a hole approximately 13 feet wide and 7 feet long at the rear of the structure (see Photo 4). The hole was located just past the basement steps. A hallway located on side Bravo led from the front room to the rear (side Charlie).

**Photo 3. View of the row houses where incident occurred. The shift safety officer was found in the Delta exposure. The shift safety officer's fire department vehicle was parked to the left (to the west) just out of view. Row houses fronting the entire city block are typical in this neighborhood. Photo taken during the NIST pressure and ventilation testing on December 11, 2014**

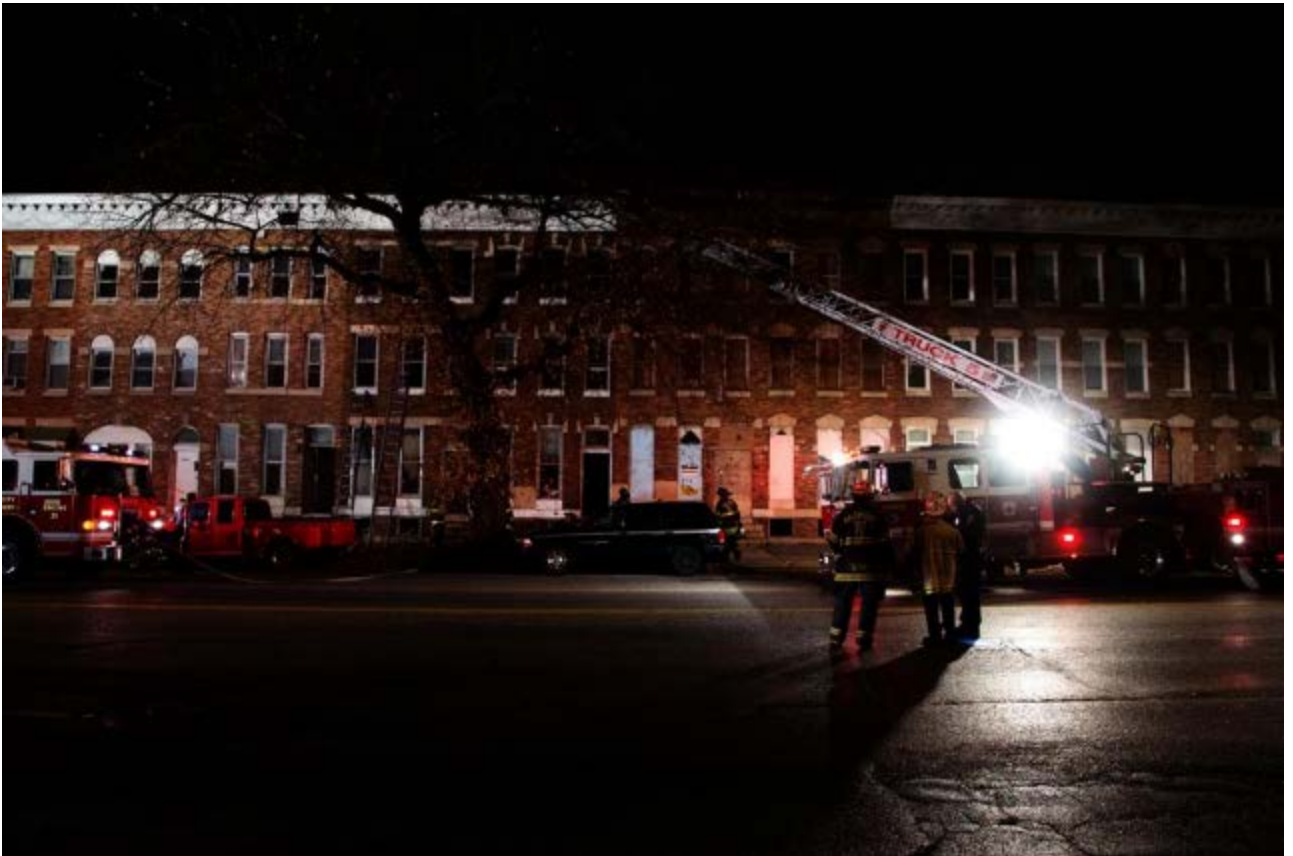
**Photo 5. Photo taken at approximately 0104 hours showing shift safety officer in street with the incident commander and another fire fighter. Photo was taken shortly before the shift safety officer entered the Delta exposure alone. (Photo courtesy of Fire Department)**

charged at the time the shift safety officer was located. The radio was found in his coat pocket with the lapel microphone attached to the upper left side (lapel) of his turnout coat. He had used the radio at least two times prior to his last documented time on the fireground (at approximately 0104 hours (see Photo 5)). These transmissions were recorded on fireground channel A-16, the correct fireground channel for this incident. The radio was equipped with an emergency activation button which was not utilized during this incident.

The shift safety officer returned to side Alpha and was observed talking face-to-face with the IC. At approximately 0056 hours, the shift safety officer radioed the E13 crew for a report on the conditions on the second floor of the Delta exposure building. A E13 crew member radioed command that there was no fire, just some trapped smoke and they were working to open up the structure. The E13 crew reported that when they returned outside, they saw the shift safety officer (SO2) at side Alpha. Photographs taken at approximately 0104 hours showed the shift safety officer in the street at Side Alpha near the incident commander (see Photo 5).

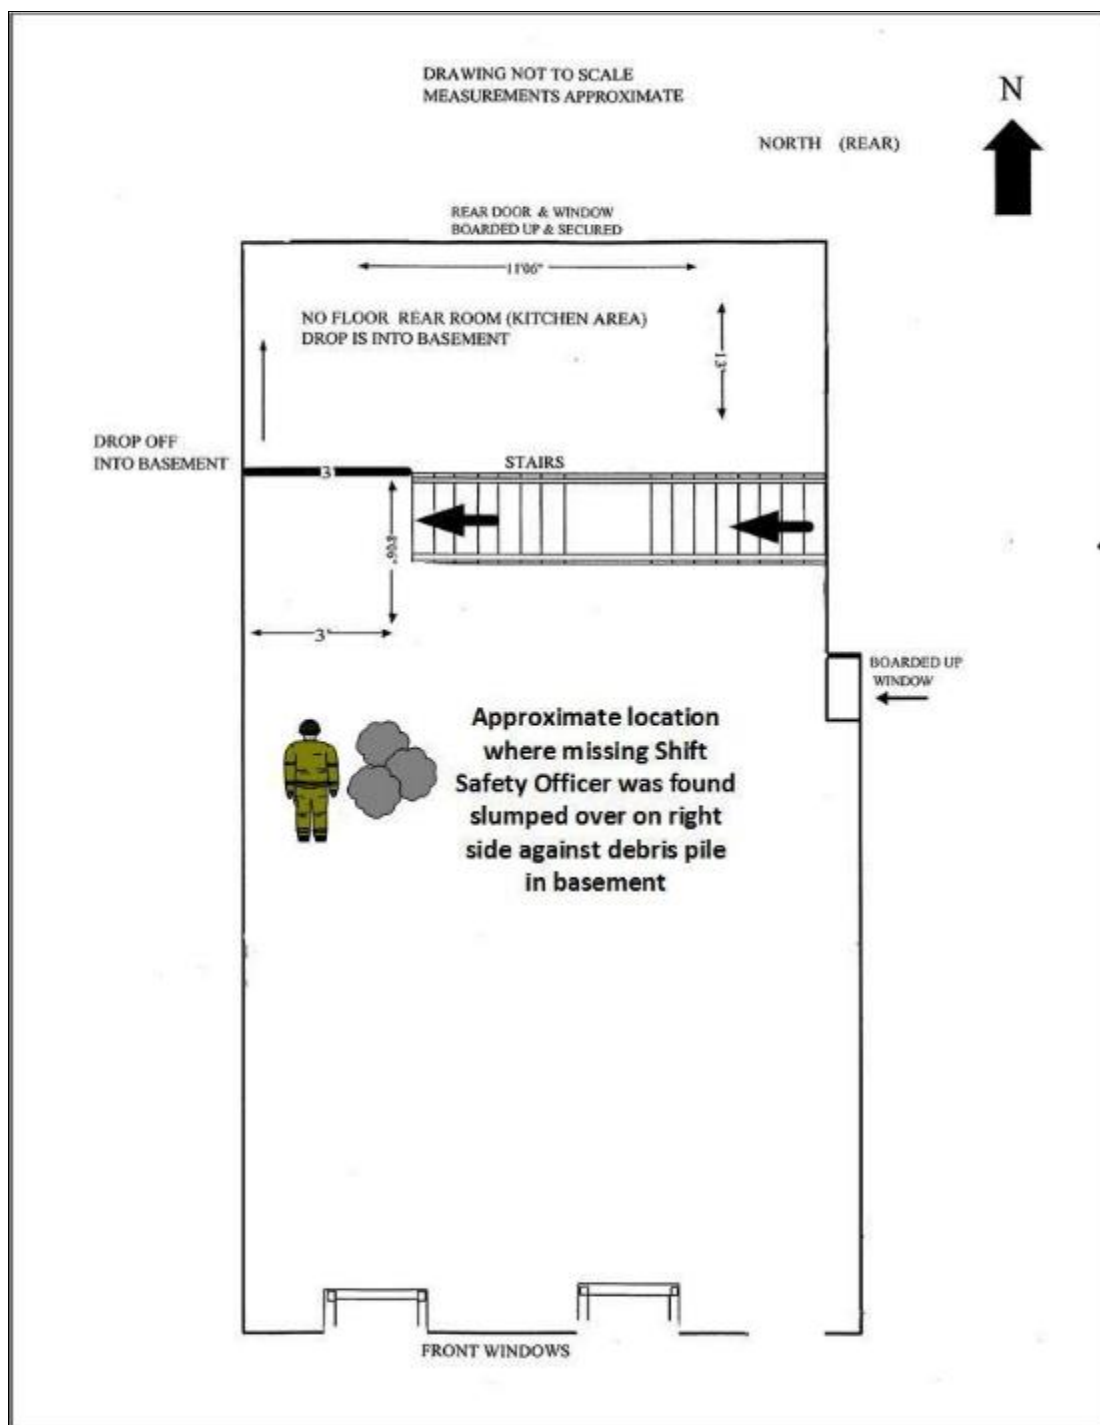
At approximately 0824 hours the E6 crew located the missing shift safety officer in the basement of the Delta exposure. He was in a sitting position near the Side Bravo wall slumped over on his right side against a pile of debris (see Diagram 2). Emergency medical services personnel were dispatched to the scene and the shift safety officer was pronounced dead at the scene at approximately 0852 hours.

**Diagram 2. Basement floor layout showing the location where the shift safety officer was found in the basement of the Delta exposure.**

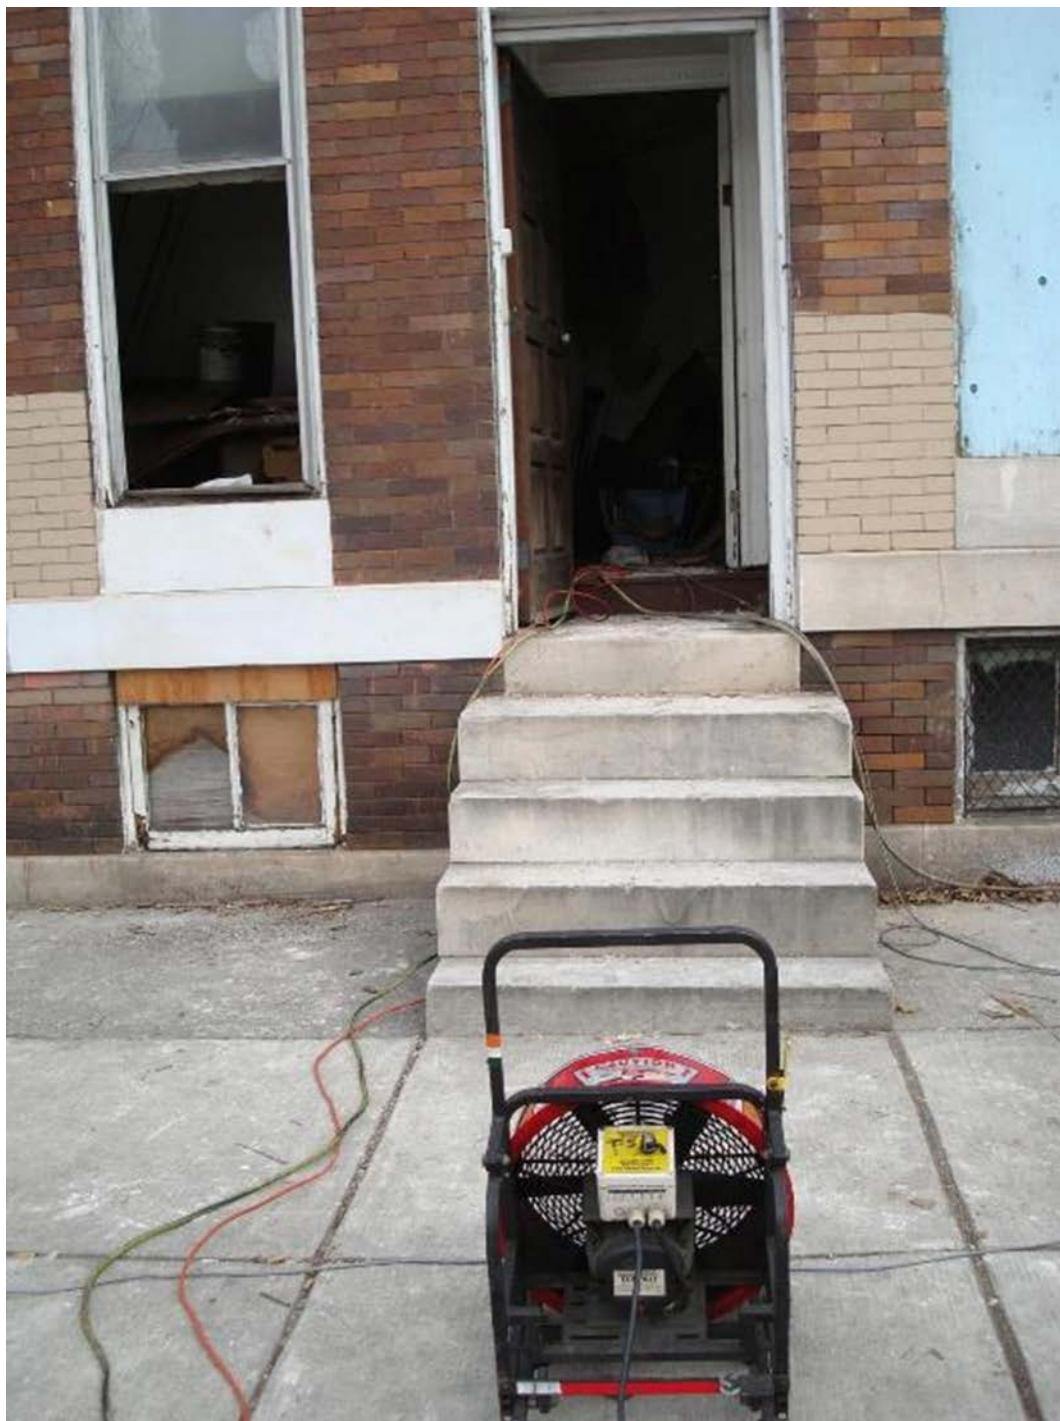
An electric smoke ejector fan was located in the front doorway of the fire building and an electric PPV style fan was set up blowing at the front doorway of the Delta exposure building (see Photo 7).

**Photo 7. Ventilation fan in front of Delta exposure. Photo taken while NIST was collecting pressure and ventilation data. (Photo NIOSH)**

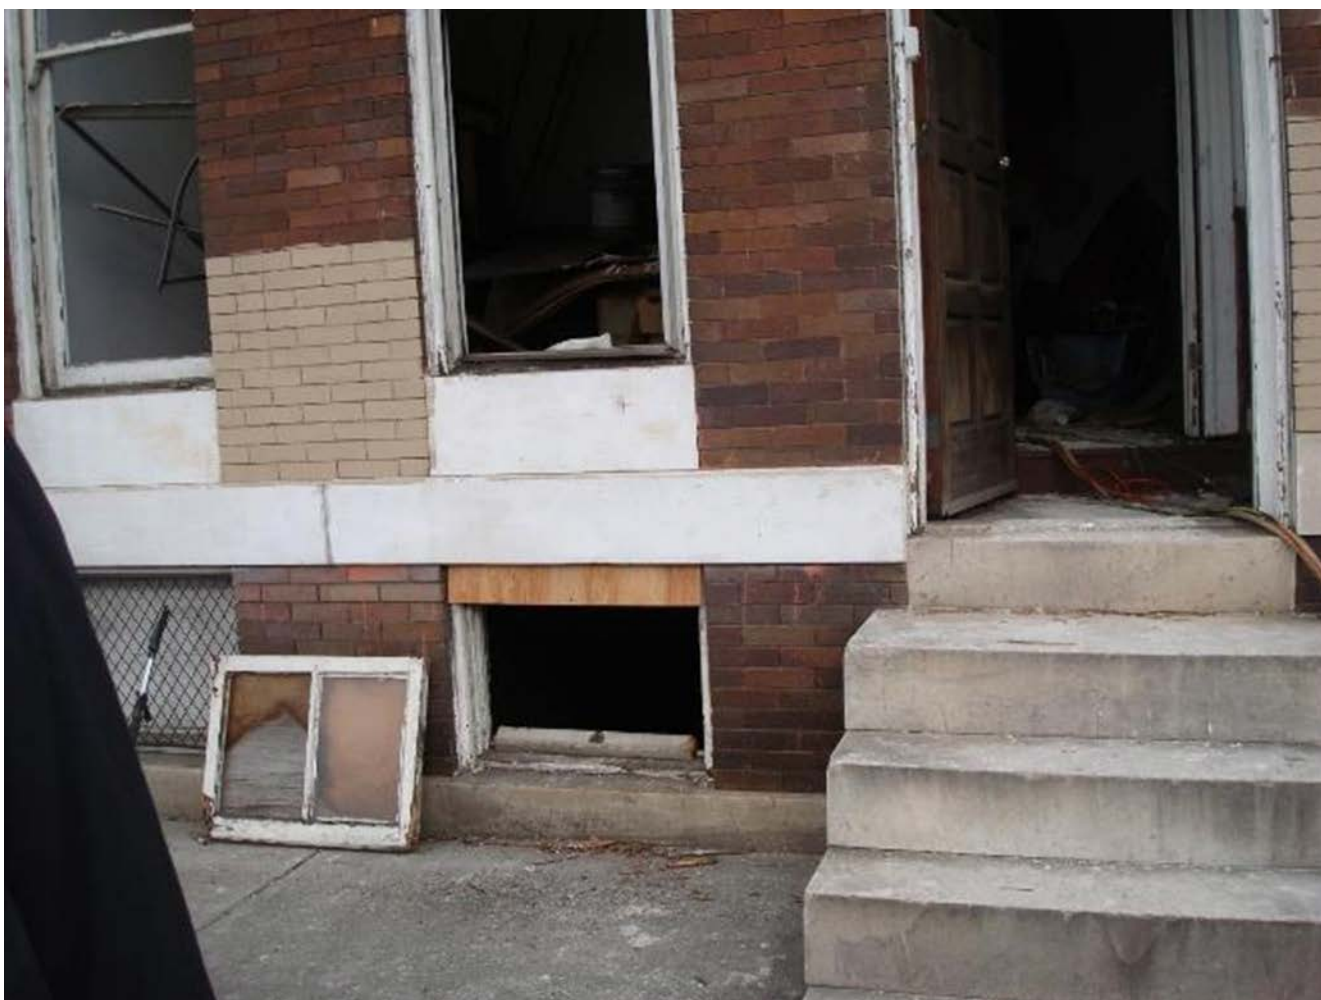
**Photo 8. Photo shows basement window at Side Alpha of the Delta exposure building removed as part of the NIST data collection process. This window was not opened the night of the incident. (Photo NIOSH)**

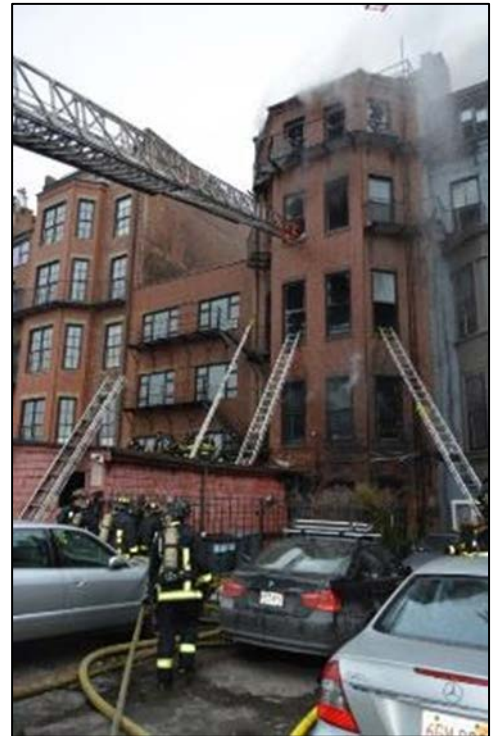
A view of fireground worker leaving the rear door of the attached shed open while investigating the smoke detector activation. The conditions became untenable for the fire fighters from Engine 7. They moved out of the building to the landing of the front steps. Also, the interior door at the top of the basement stairs was open, the front exterior doors were left open by an occupant fleeing the fire, and a rear basement door or window failed. Once the rear door or window burned through, this created an unrestricted flow path from the basement to the first floor plus the floors above, thereby triggering a rapid progression of fire conditions. This trapped the officer and fire fighter from Engine 33 in the basement. The fire, heat, and smoke through the basement and first floor created untenable conditions on both floors. Due to the intense heat and fire conditions, the 1¾-inch attack hose burned through. Command then ordered the building to be evacuated. Approximately 1 minute later, the Engine 33 lieutenant called Command and said they were running out of water. The dispatcher replied, "OK Engine 33, we are going to get you water." Command immediately called a second alarm for Box 1579. Several companies tried to make entry into Side Alpha from both the basement and the first floor of the structure, but were pushed back by heavy fire and smoke. Crews pushed through the Side Bravo exposure to initiate fire attack on Side Charlie. Crews took a 2½-inch hoseline into the basement apartment on Side Charlie. Approximately 15 minutes later, crews located the fire fighter from Engine 33 in the kitchen area of this apartment. The fire fighter was removed from the apartment and immediately taken to an ambulance for transport to the hospital. The fire fighter from Engine 33 was pronounced dead at the hospital. After the fire fighter was removed, conditions changed and the structure became fully involved. Crews were removed from the structure and the strategy was changed to defensive operations. Once the fire was completely knocked down and conditions allowed fire fighters to safely re-enter the structure, a search was made for the lieutenant of Engine 33. The lieutenant was found at the bottom of the stairs near the entrance to Apartment #10 in the basement. The lieutenant was pronounced dead at the scene.

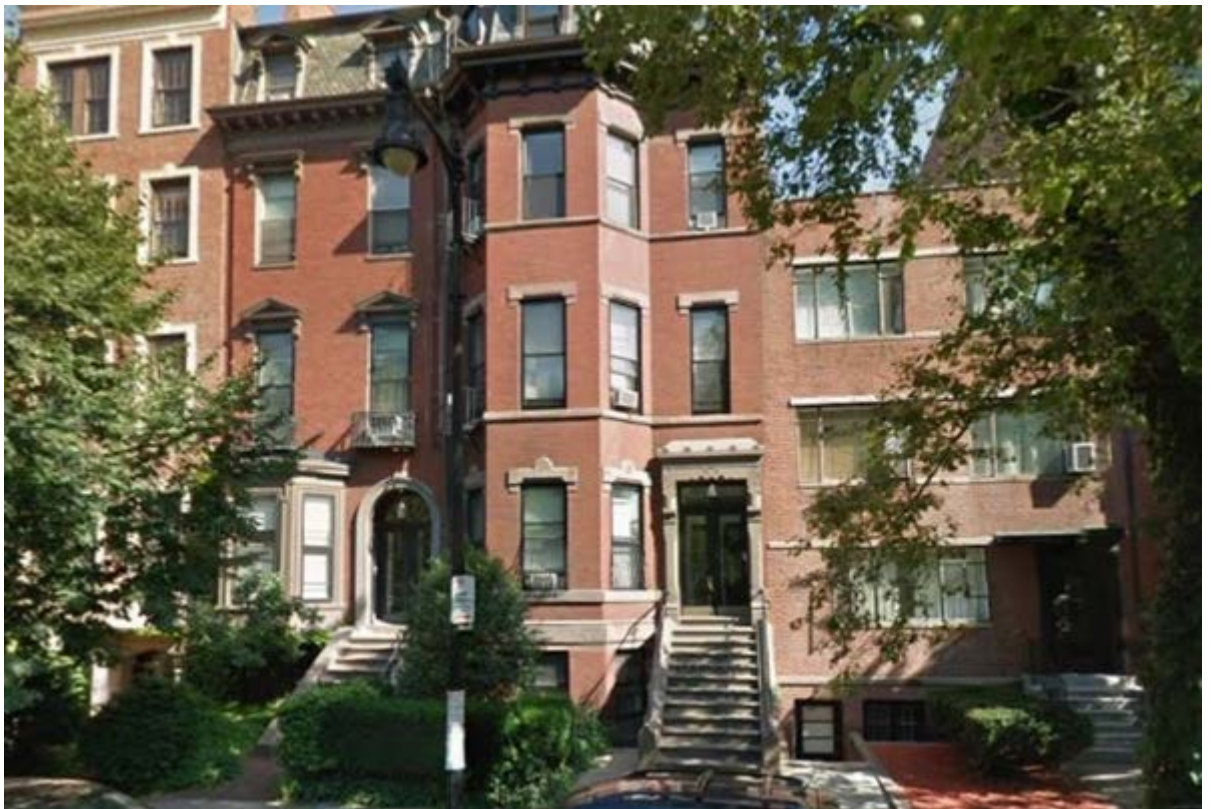
**Photo 1. The fire building is the one with the bay windows from the basement to the fourth floor. The entrance to the basement apartment is under the steps.**

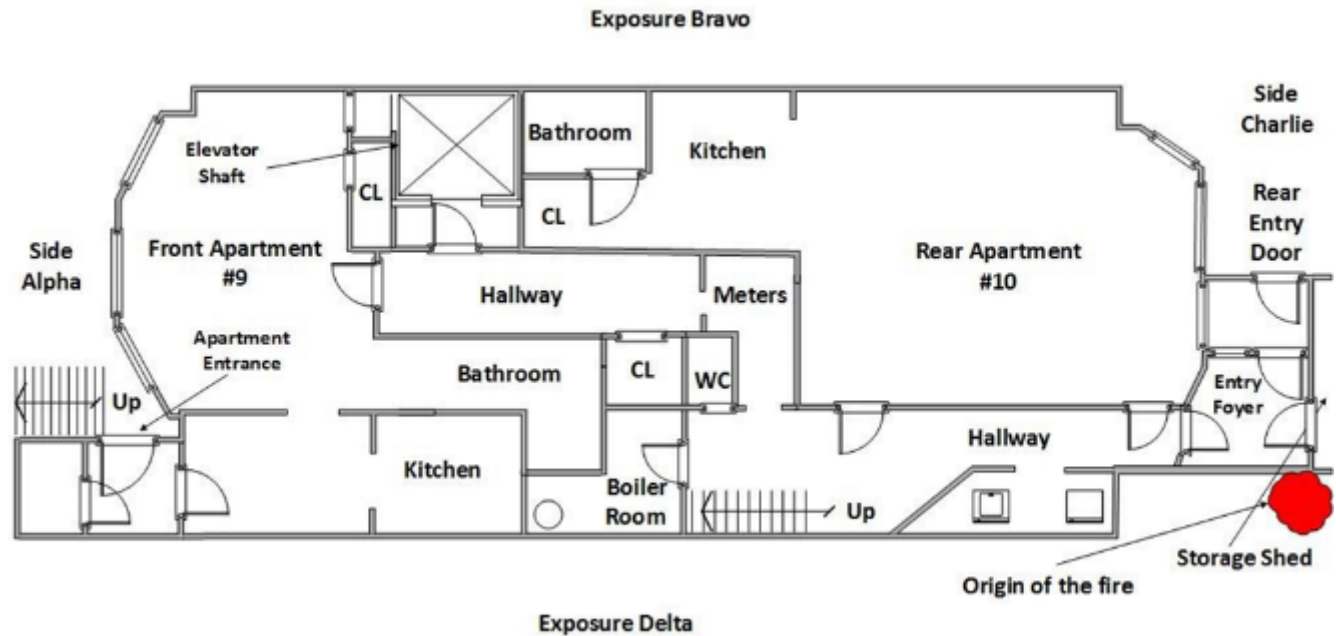
When built, the structure was designed as a single-family dwelling. In 1974, the owner divided the building into apartments with one apartment each on the first floor and the second floor and with two apartments each in the basement, third floor, and fourth floor. The basement was divided into two separate apartments with separate entrances. The basement unit at the front of the building (Apartment #9) could only be entered from the exterior entrance below the stairs on Side Alpha. The basement unit at the rear of the structure (Apartment #10) could be entered from the interior stairs at the center of the common hall on the first floor and from an exterior grade-level entrance on Side Charlie (**See Diagram 1**). The main entrances to the apartments on the second through fourth floors were reached by a common interior stairwell. Secondary means of egress from apartments on the first through fourth floors were provided by exterior fire escapes.

**Diagram 1. The diagram of the basement of the fire building. The front apartment is #9 and the rear apartment is #10. The shed was attached to the structure on Side Charlie, behind the rear entrance doors for the rear apartment.**

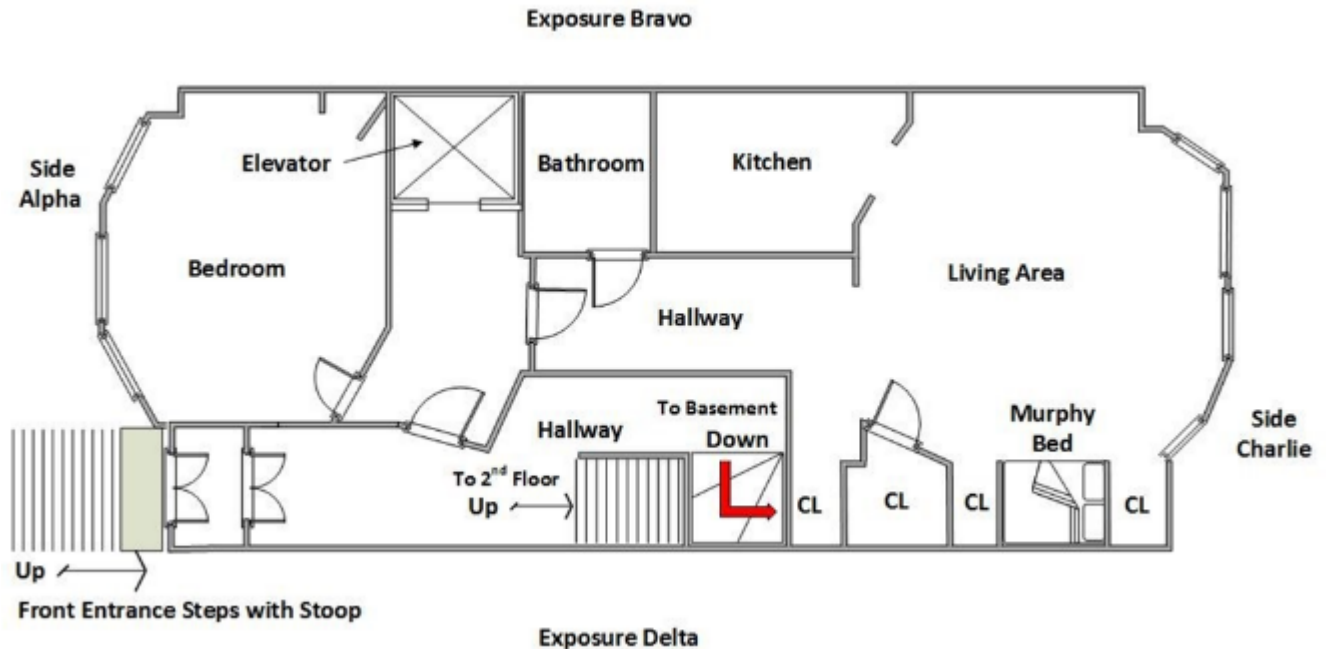
The first floor consisted of one apartment, which included a bedroom in the front (Side Alpha), a large living area in the rear (Side Charlie), a kitchen, a bathroom, another bedroom, and a common entry foyer, which had access to the basement (Apartment #10) and the apartments on the floors above (**See Diagram 2**). Prior to its conversion to apartments, the building had an elevator that went from the basement to the first floor. The elevator had been used to bring prepared food from the basement to the first floor when the structure was a single-family dwelling. The elevator was not in service at the time of the fire. The elevator was located on the Side Bravo wall.

**Diagram 2. The diagram of the first floor (Apartment #1) of the fire building. The stairs leading down to the basement are marked by the red arrow.**

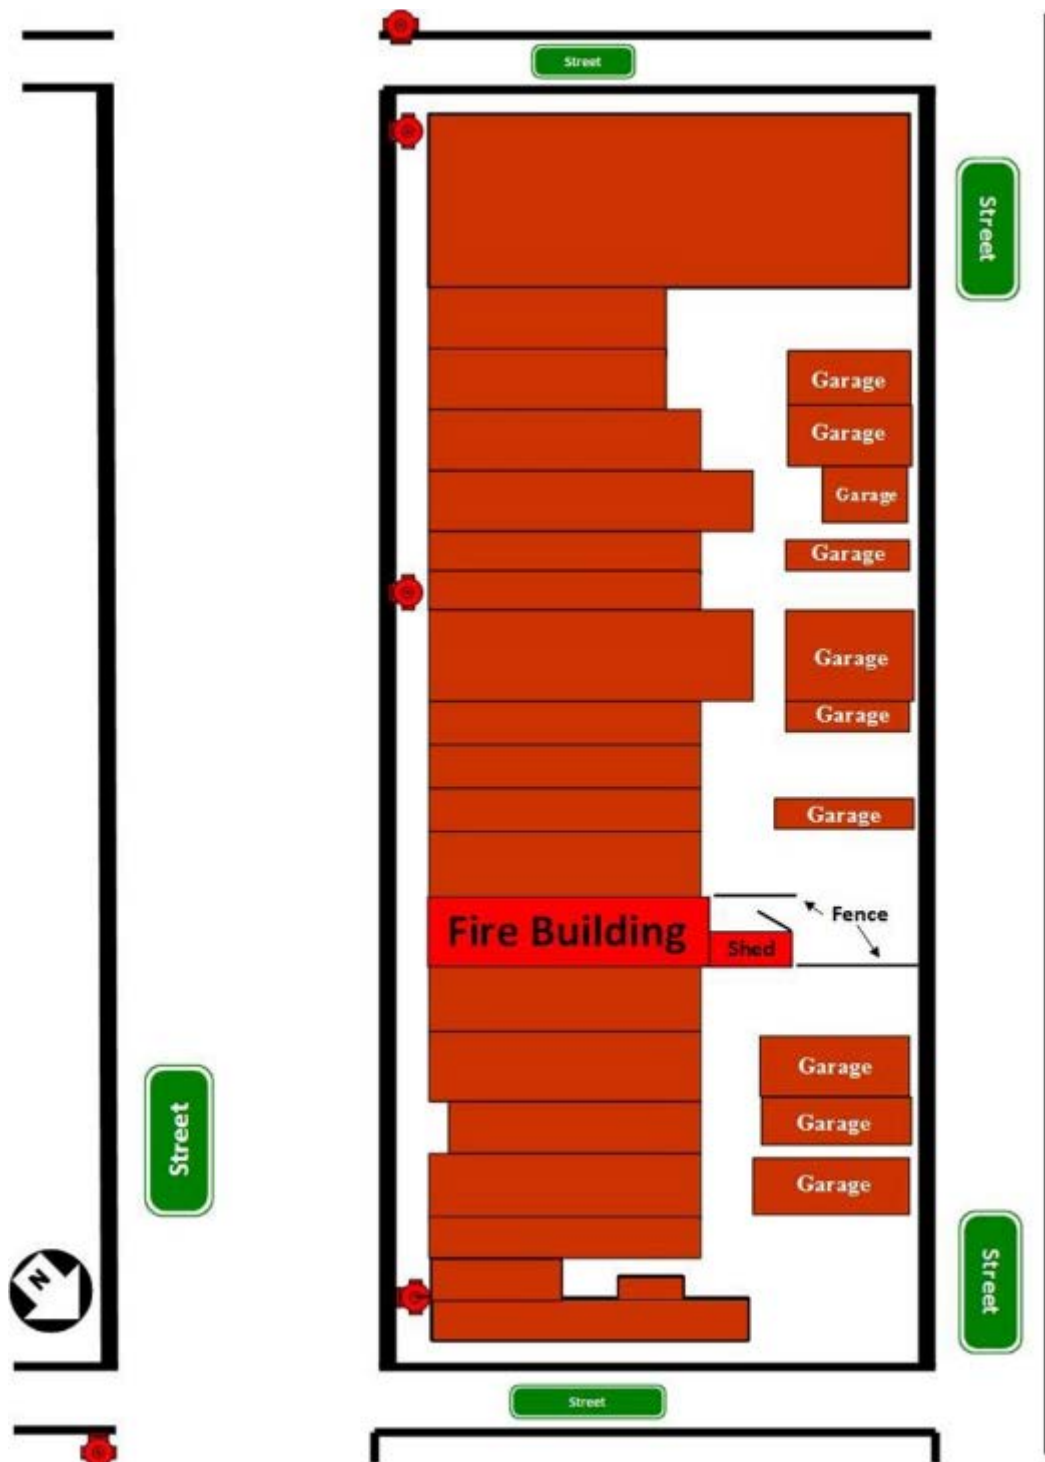
The block where the fire occurred consisted of predominately brownstone buildings. In-fill structures abutted the buildings on either side of them, just as the original structures did. Parking was allowed on the street in front of the buildings. Parking was also allowed on a private, narrow street on the Charlie side of the building. As indicated in the diagram, several buildings had garages for tenant parking (**See Diagram 3**).

**Diagram 3. The street diagram and location of the fire building.**  
[Lieutenant and Fire Fighter Die and 13 Fire Fighters are injured in a Wind-driven Fire in Brownstone – Massachusetts.](https://www.cdc.gov/niosh/fire/pdfs/face201409.pdf#page=29)

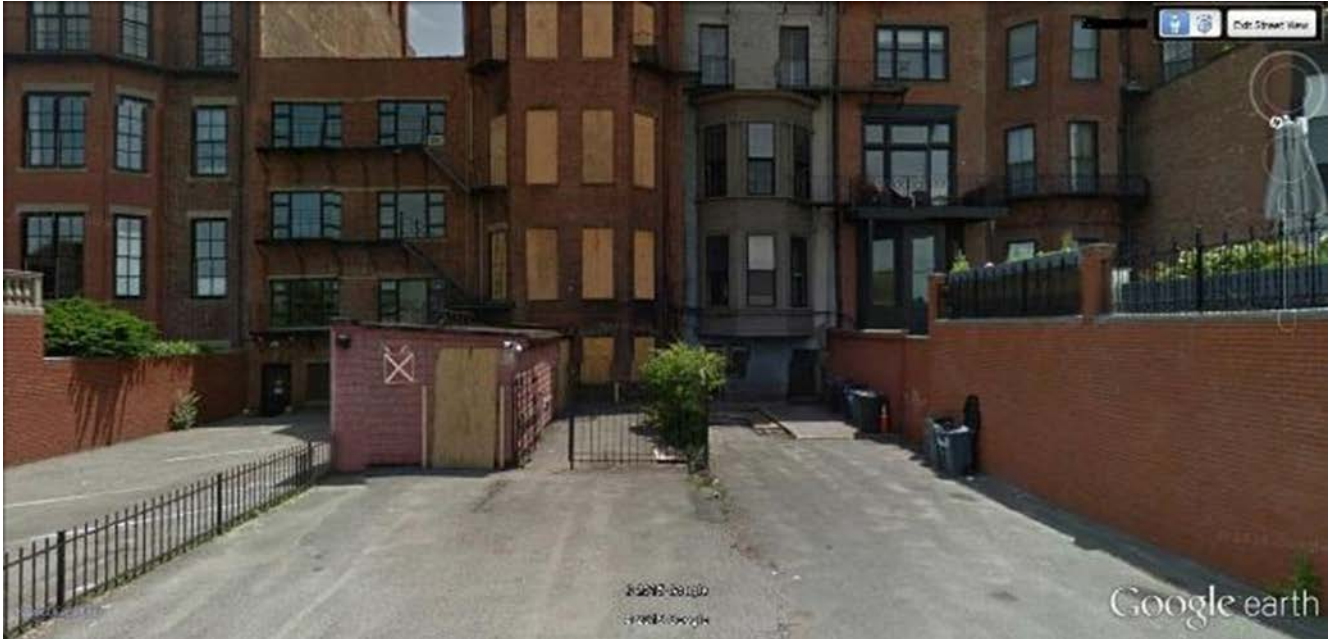
The fire started in a shed in the rear of the structure. The shed was attached to the building by the rear entrance. The shed served as the office, storage, and work facility for the property maintenance staff of the affected building (See **Photo 2**).

**Photo 2. A view of Side Charlie and the location of the maintenance shed.**  
(Photo source: Google Earth.)

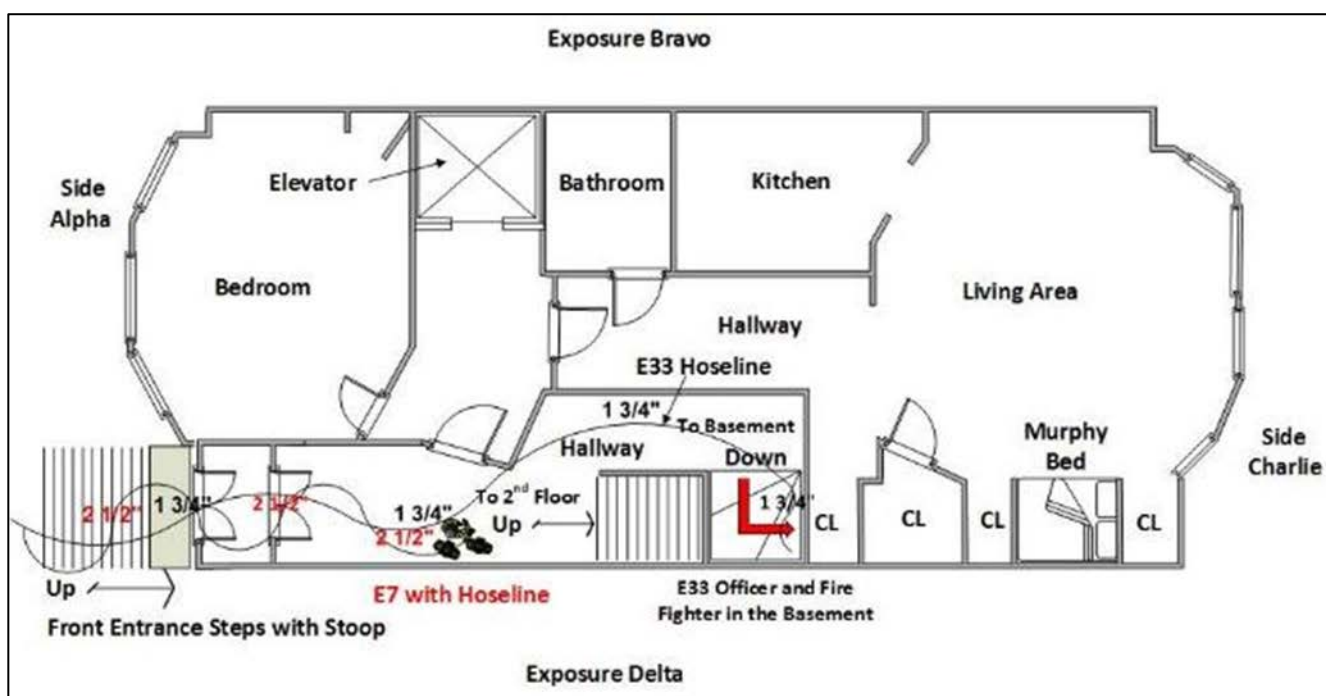
Engine 7 arrived on scene at 1447 hours from the east and parked facing Engine 33 and laid a 4-inch supply line from the hydrant on the corner and then ran a 2½-inch supply line to Engine 33. Engine 33 was entering the front door as Engine 7 arrived on scene. The crew (officer and two fire fighters) from Engine 7 pulled a 2½-inch hoseline to the front steps. Engine 7 stretched a 2½-inch hoseline up the front steps following Engine 33's charged 1¾-inch hoseline. As Engine 7 moved the hoseline toward the stairs, the conditions started to change as the first floor became extremely hot. The Pipeman from Engine 7 asked the Engine 7 officer to call for water. The conditions became untenable and Engine 7 left the building. As Engine 7 pulled the 2½-inch hoseline out of the building, the hose was burned. The time was approximately 1449 hours (**See Diagram 4**).

**Diagram 4. The initial hoseline operations entering through the front door of the first floor.**

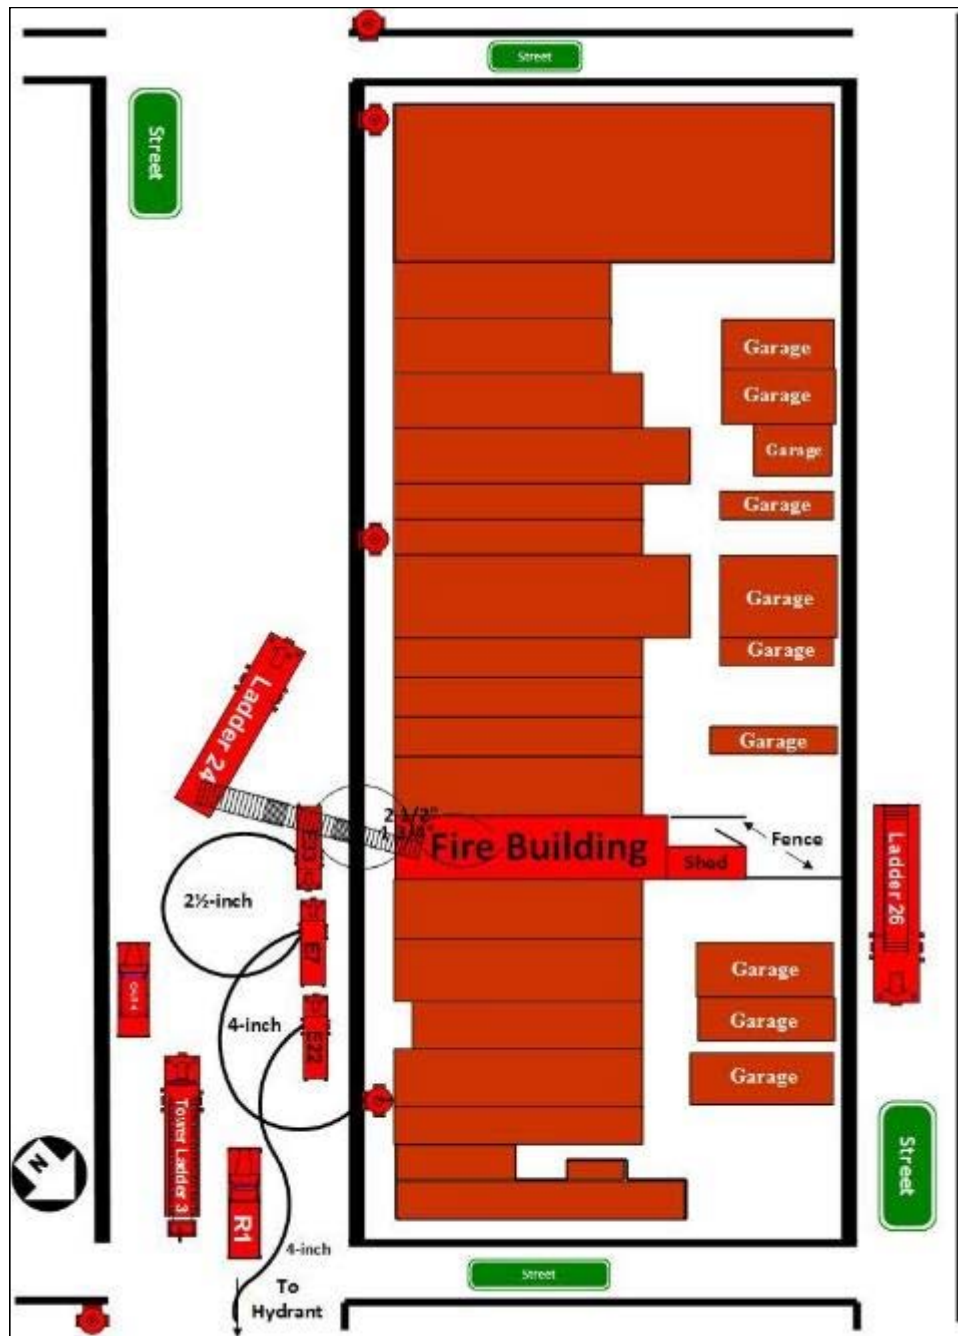
Ladder 26 arrived on scene at 1448 hours and parked on Side Charlie, directly behind the fire building. The captain of Ladder 26 observed the rear door of the maintenance shed was open and fire in the shed. The captain advised his crew not to break any windows. The captain radioed Command and asked for water on Side Charlie but was unable to reach Command due to radio traffic. He instead called FAO and advised that fire was showing on the first floor in the rear of the building. He requested an engine company on Side Charlie for water. The captain of Ladder 26 then forced his way through Exposure Bravo to get to Side Alpha (**See Diagram 5**).

**Diagram 5. The diagram of the initial engine company operations with Engine 33, Engine 7, and Engine 22 making entry into the fire building. The time is approximately 1449 hours.**
