**Nine Career Fire Fighters Die in Rapid Fire Progression at Commercial Furniture Showroom — South Carolina**

Fire Fighter Fatality Investigation and Prevention Program

*A summary of a NIOSH fire fighter fatality investigation*

February 11, 2009

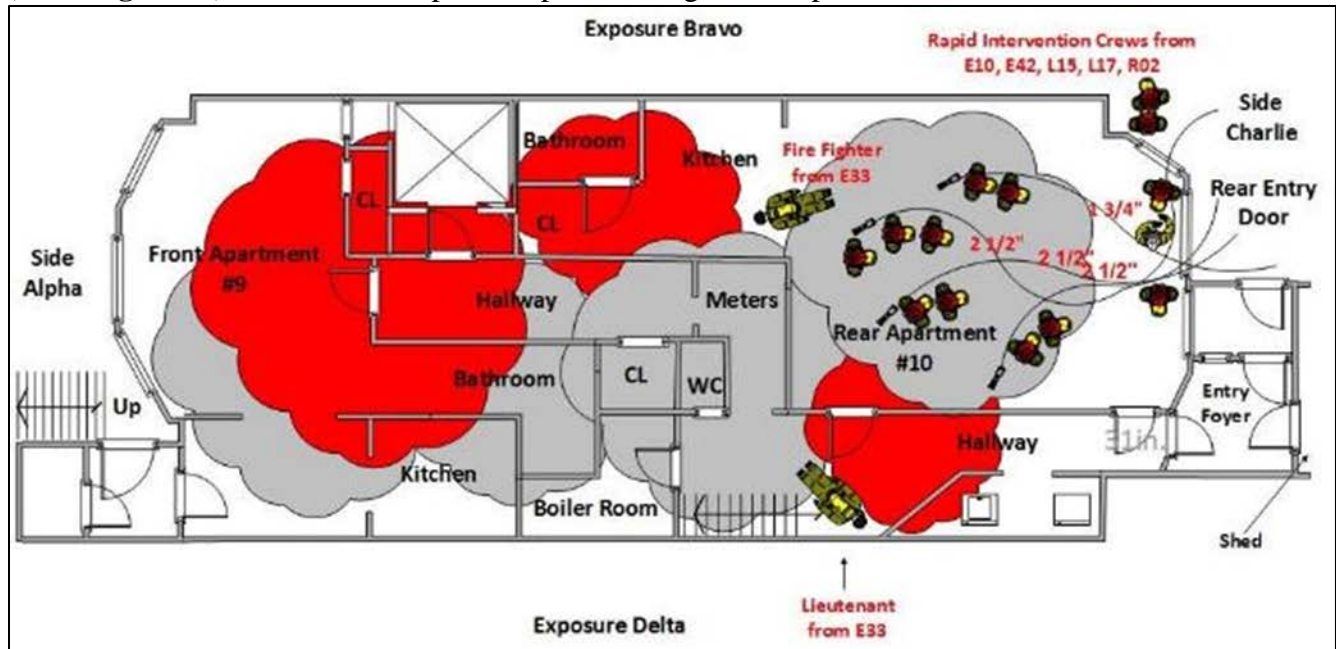
Rescue 2, Ladder 17, Ladder 15, Ladder 26, Tower Ladder 3, and Engine 42 were operating on Side Charlie. Members from Rescue 2 found the fire fighter from Engine 33 in the rear basement (Apartment #10) near the kitchen. The fire fighter was covered with debris. Members of Rescue 2 moved the fire fighter from Engine 33 to the rear window (See Diagram 6). Crews outside picked up the fire fighter and put him on a stretcher.

**Diagram 6. Crews from Engine 10, Engine 42, Ladder 15, Ladder 17, and Rescue 2 are operating the rear basement apartment searching for the lieutenant and fire fighter from Engine 33. Rescue 2 finds the fire fighter from Engine 33 and removed him from the building. The time is 1519 hours. The lieutenant was not located until 1848 hours.**

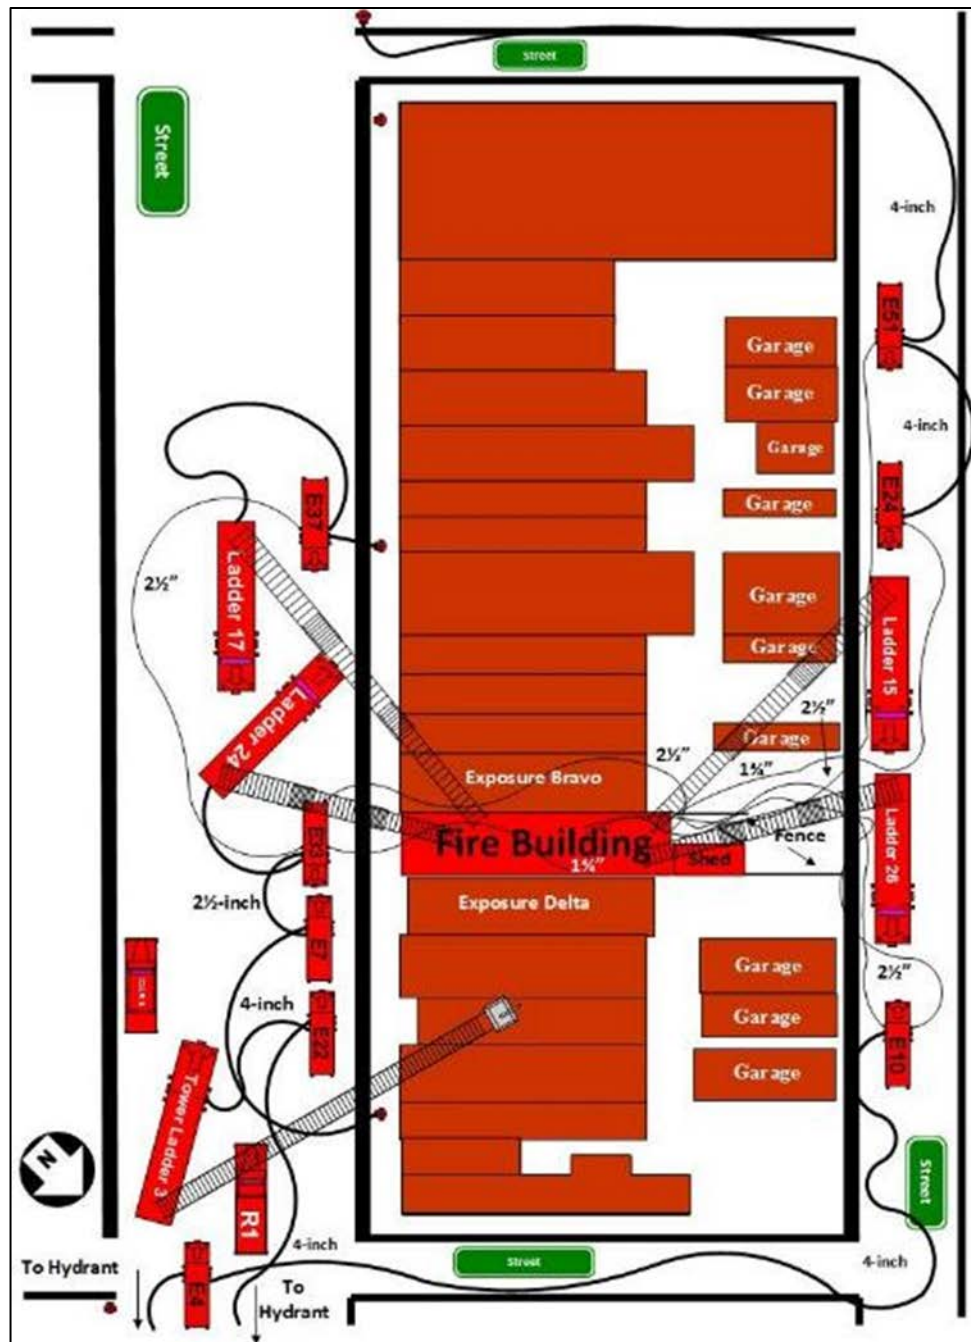
**Diagram 7. Defensive operations. Ladder pipes, a tower ladder, and numerous deck guns plus hoselines are in operation. The time is approximately 1645 hours.**

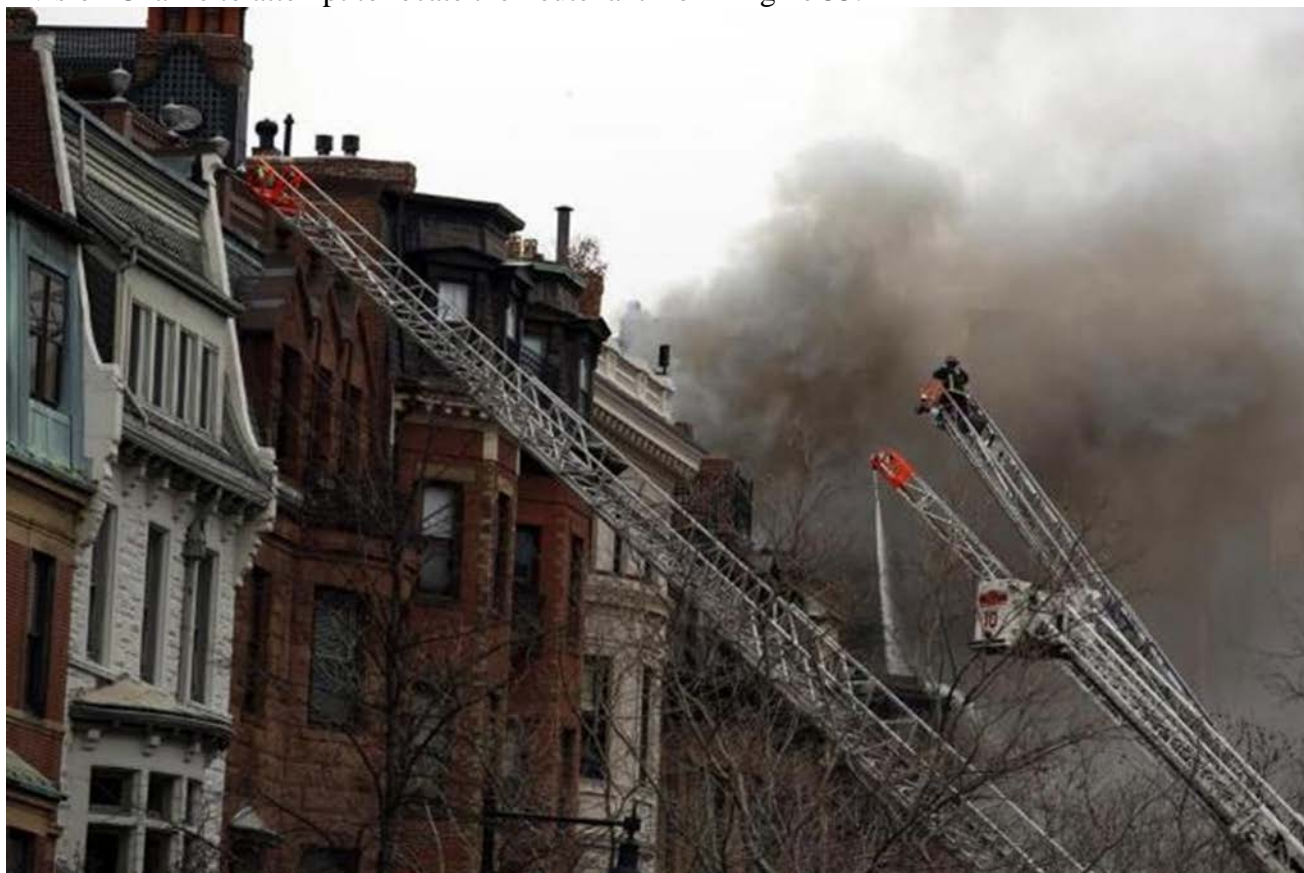
The defensive operations continued on Side Alpha and Side Charlie until approximately 1635 hours (See **Diagram 7** and **Photo 4**). At 1831 hours, a request was made for a chief inspector from the city's Inspectional Services Department, a structural engineer, and the medical examiner. At 1840 hours, a request was made for the structural engineer to report to Division Charlie. After consultation with a structural engineer, Command advised Division Charlie to attempt to locate the lieutenant from Engine 33.

**Photo 4. Defensive operations on Side Alpha of the fire building. Three ladder pipes, a tower ladder, numerous deck guns, and hoselines are in operation. The time is approximately 1615 hours.**

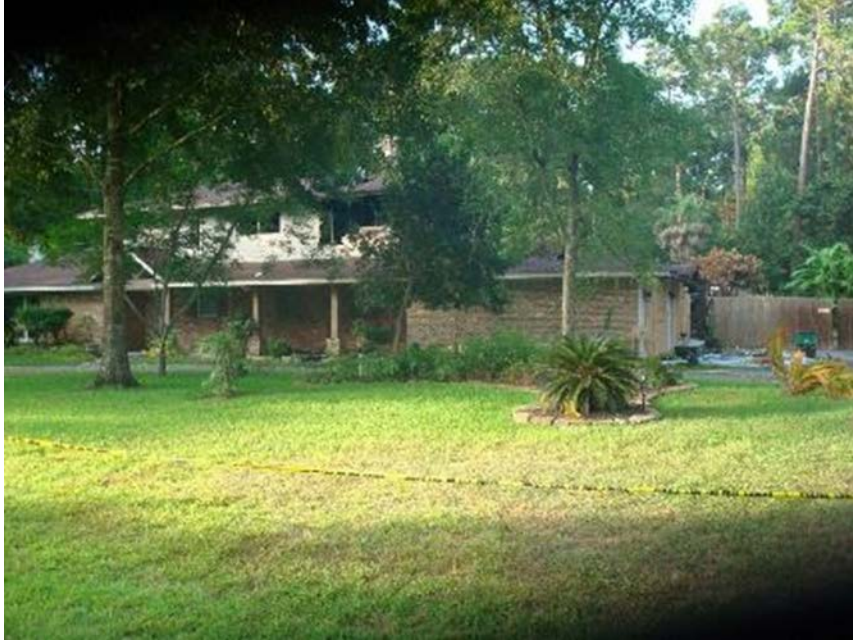
The residential structure was built in 1963 and was wood frame construction on a slab foundation (see Photo 1). The two-story ranch had been remodeled in 2012 and consisted of 4,608 square feet of living space. The first floor consisted of a large living area, large kitchen, full bathroom, master bedroom with full bath, attached two-car garage, and an attached storage shed, which contained ammunition reloading equipment, ammunition components, and ammunition. The second floor had two bedrooms, a full bath, and a sewing room with French doors that led out onto a deck (see Diagrams 1 and 2). The first-floor exterior was covered with brick, and the second floor was oriented strand board covered with vinyl siding. In the rear of the structure, the first floor had a covered patio and the second floor had a large deck.

**Photo 1. Residential structure Side Alpha.**  
*(NIOSH photo.)*

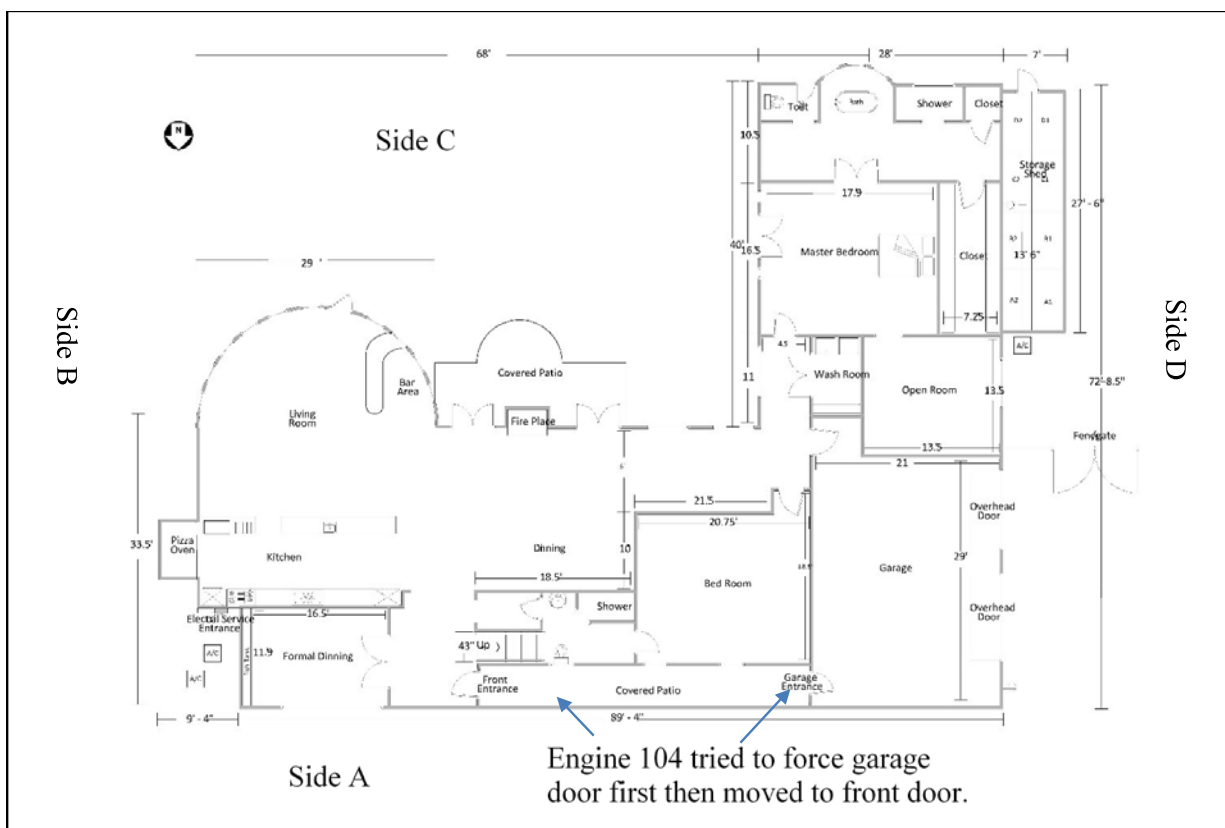
**Diagram 1. First floor layout and general dimensions. Image shows Engine 104 tried to force garage door first then moved to the front door on Side A.**

door on Side Alpha (see Diagram 1). FF1 was using a sledgehammer but was only able to open the door a foot while FF2 tried knocking down the fire on Side Delta of the structure. When FF1 was swinging the sledgehammer, his mask-mounted regulator (MMR) was swinging freely and hitting the SCBA donning switch. The captain informed FF1 that he was losing air. This occurred several times. It is believed that FF1 may have turned off his cylinder valve at that time. The Engine 104 pump operator engaged the pump then took 100 feet of 4-inch supply hose toward the hydrant on the Alpha/Bravo corner of the street.

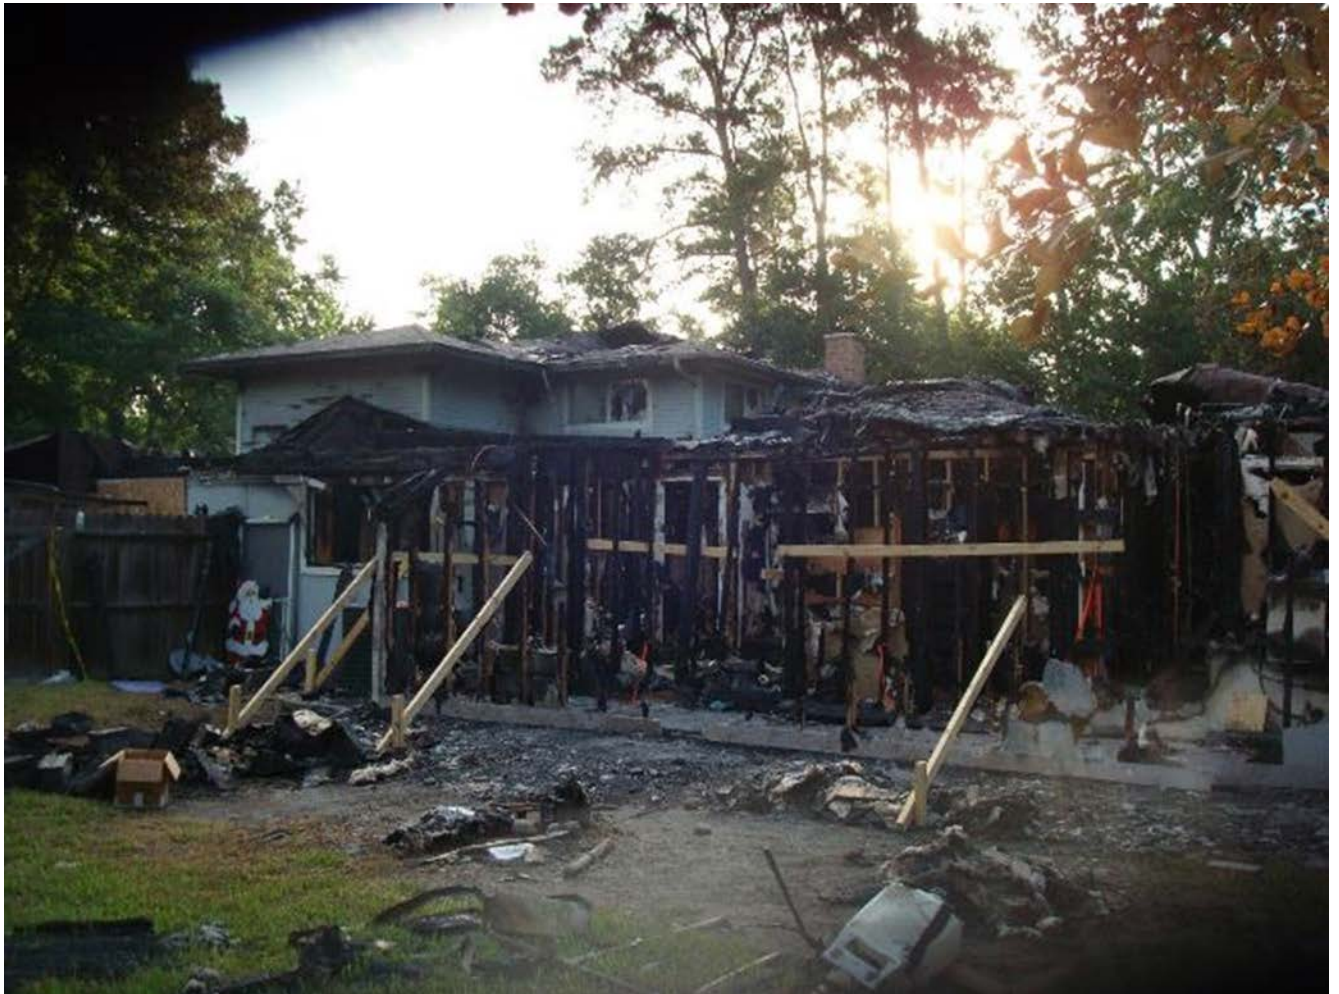
**Photo 2. Side Delta of fire structure where the area of origin of the fire occurred.**

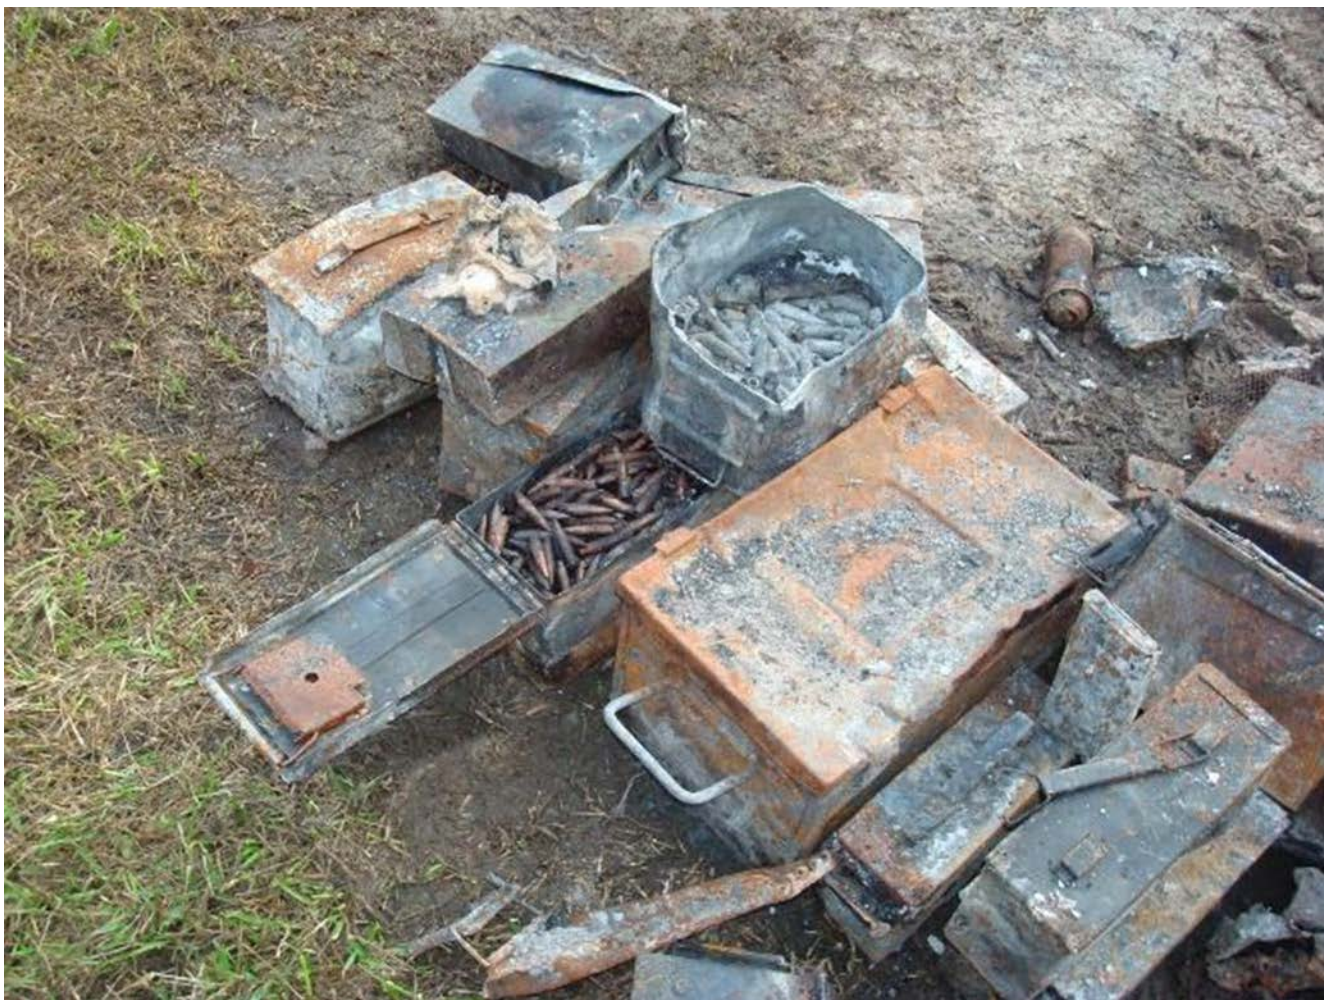
**Photo 3. A sample of ammunition and reloading supplies found on Side Delta.**  
(*NIOSH photo.*)

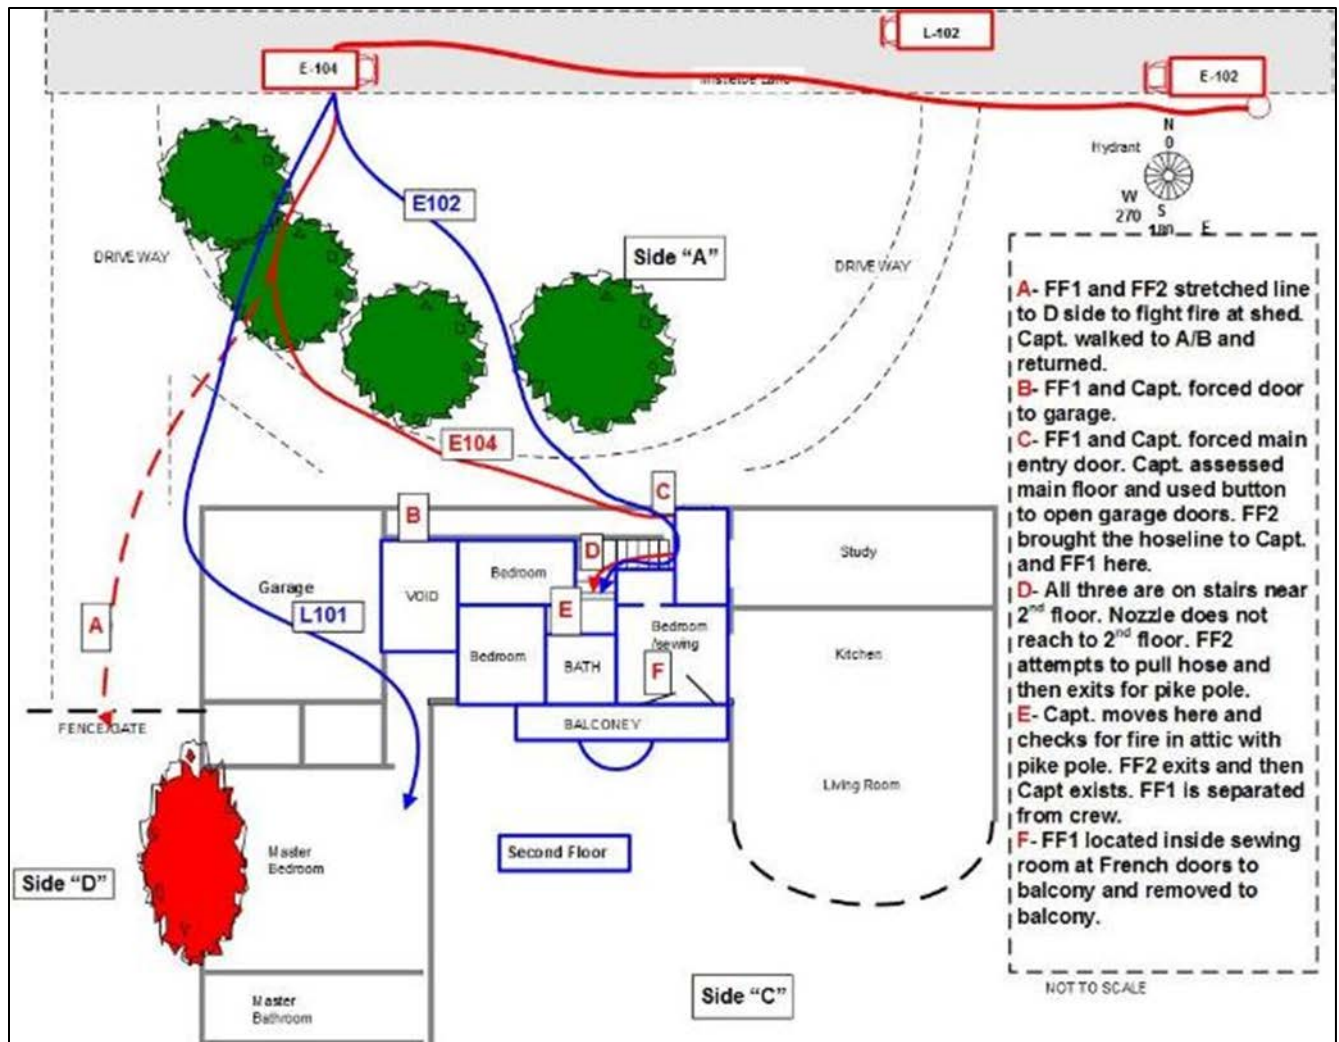
At 1610 hours, Engine 102 arrived on scene and was ordered to pull a second hoseline to back up Engine 104 (see Diagram 3). Engine 103 arrived and was assigned as the RIT. The Engine 104 captain and FF1 had opened the interior man door to the garage and opened both garage doors and saw no smoke in the garage. After seeing only minimal smoke, no visible fire or civilians on the first floor, the Engine 104 captain and FF1 proceeded up a narrow stairway to the second floor where they met up with FF2, whom had tried to pull more hoseline to reach the top of the stairs. Engine 104 Captain requested a pike pole so, FF2 went and got it.

**Diagram 3. Key apparatus and hoseline placement.**  
(Courtesy of the State Fire Marshal's Office.)

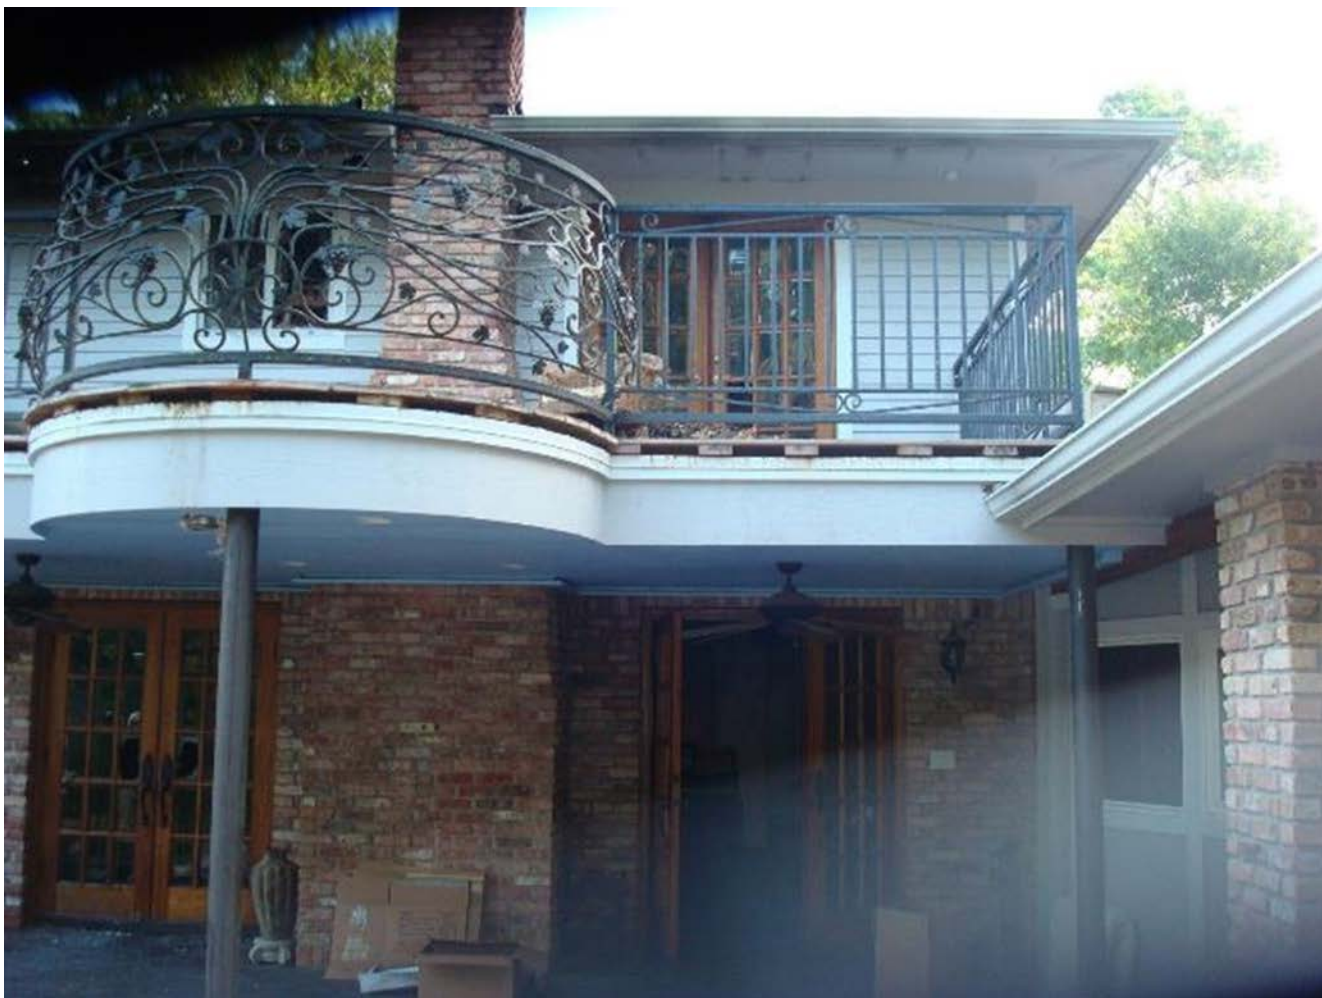
At 1628 hours, DC64 notified the RIT that FF1 would be in the second floor bedroom to the left. Minutes later, the Engine 63 made entry through the exterior Side Charlie double doors on the balcony to the room on the second floor (see Diagram 3, Notation F, and Photo 6). The Engine 63 engine operator notified Command they had FF1 on the balcony (see Photo 7). Engine 63 and the RIT took him down a ladder off the balcony to the yard.

**Photo 7. The second floor balcony where FF1 was brought out and lowered to the ground via a ground ladder. (NIOSH photo.)**
